CHARLOTTESVILLE MAIN STREET

Tree Assessment and Management Recommendations

Prepared for:
City of Charlottesville, Virginia

December 11, 2015

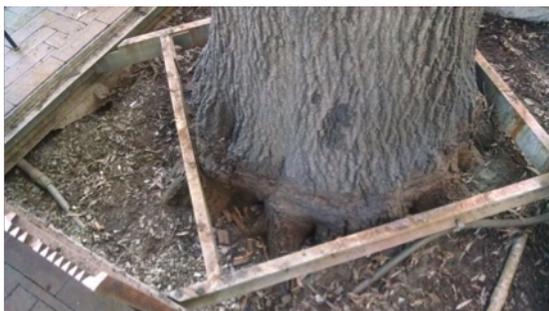
Under the tree grates is a steel beam support. Some of the faster growing trees are beginning to contact this support. This trunk to beam contact is of equal threat to the trees as the trunk to grate contact, but remains hidden from view. Fixing this problem will pose a greater challenge than presented by the grate as it involves a reconfiguration of the structure of the grate system.

Tree grate support beam

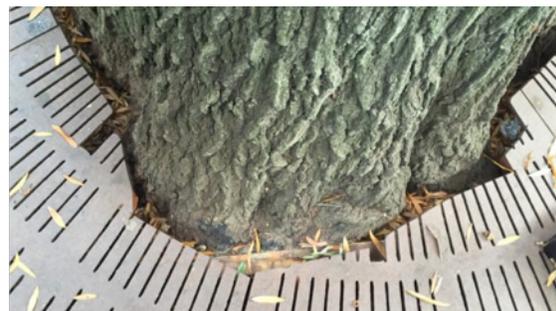
Beam in contact with trunk

The conflict between the underlying grate frames and the trunk flare must also be resolved and the repairs to frames must be undertaken with methods that do not damage the living root tissue in contact with the steel support beams.

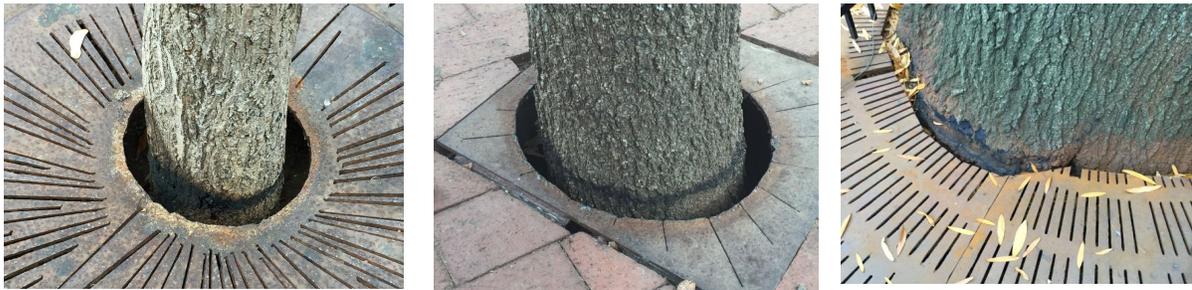
The maintenance to enlarge the grates and plates are causing damage to the trees in many instances. It appears that when the work to enlarge the holes is performed the grates and plates are left in place. When the plates are cut they appear to be cut with a cutting torch. This heats up the plate and there are many trees where the trunk bark is burned. In some cases it was clear that the cambium layer was damaged by this heating. In other trees it is not clear how much damage this process is causing. When the cast iron grates are cut the cutting appears to be done with some type of saw or grinder. In several instances the tool has cut into the trunk through the cambium layer. Some of the large oaks were also observed to have been burned during the enlargement process. **Trees, notably # 29, 36, 37, 38, 39, 50, 61, 62, and 65 are damaged.** These are noted on data sheets. **Significant wounding that has occurred on trees #29, 61, and 62, related to the expansion of the steel grates around these trees. This type of damage must be avoided.**

Trees damaged by burning during grate enlargement

Why is damage to the cambium layer a problem? The cambium layer of a tree is the critical growth region for the tree and the zone where water and carbohydrates (sugar) move through the tree. A thin layer of wood cells called the phloem just outside the cambium are the primary vessels that move sugar down to the roots. Inside the cambium layer is the xylem layer that move water up the tree. Damage to these layers is serious. Oaks are ring porous trees meaning that distinct sets of wood vessels in these layers connect specific sections of roots to specific limbs in the tree. Once these vessels are cut it is difficult for the tree to support those roots and branches.

It is too early to tell how much damage has been done by the cutting and heating of the cambium layers, but it is clear that in the future, plates and tree grates MUST be removed during the cutting process.

The conflict between the tree base and the paving is the most serious threat to the trees on the Mall and is the one thing that must be resolved quickly. It is strongly recommended that the grates be removed and replaced with a more suitable approach. See the Recommendations section below for an alternative idea.

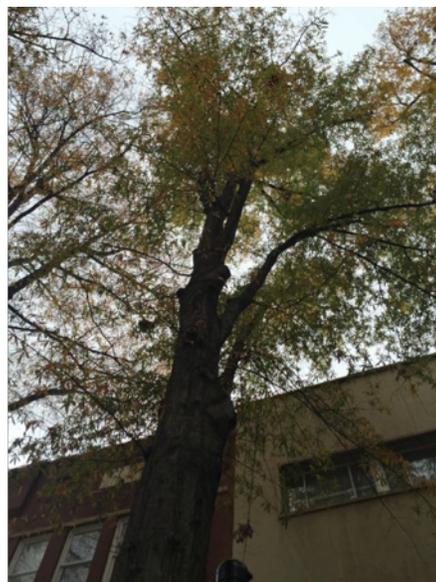
The City should avoid situations where pruning leads to trees with the live canopy concentrated in a small portion of the upper trunk. The measure of a tree’s live canopy relative to its height is termed the “live crown ratio,” or LCR. When a tree’s LCR is 30%, or less, the trend is toward a tree that is inherently unstable. A low LCR will also result in a tree with smaller trunk taper. LCR has implications for tree vigor, structural integrity of the main stem, and stability at the base. Several of the Willow oak on the Mall are trending toward this condition.

Tree with low Live Crown Ratio

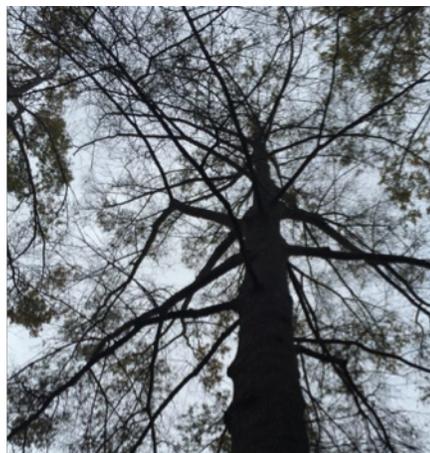
Significant root damage occurred within the area of the oaks at the western end of the Mall. These are trees #69-73. Excavation related to the installation of a new utility alignment occurred in close proximity to them, which has resulted in a noticeable decline in the live crown percentage, and vigor.

Stressed tree from root damage

At the time of this inspection, it was not possible to get a good sense of just how much live canopy exists because the leaves had been shed, and a close inspection of the viable buds was difficult from the ground. However, our initial evaluation of the tip extension indicates that they are growing slowly, and are in poor condition. Tree #71 is in the worst shape of the group, and likely represents a candidate for removal. However, the remainder may have enough live canopy to warrant retaining them, and providing chemical intervention in the form of a tree growth regulator treatment.
