Charlottesville Downtown Mall **TREE MANAGEMENT PLAN**

RECOMMENDATIONS + APPENDICES

2024

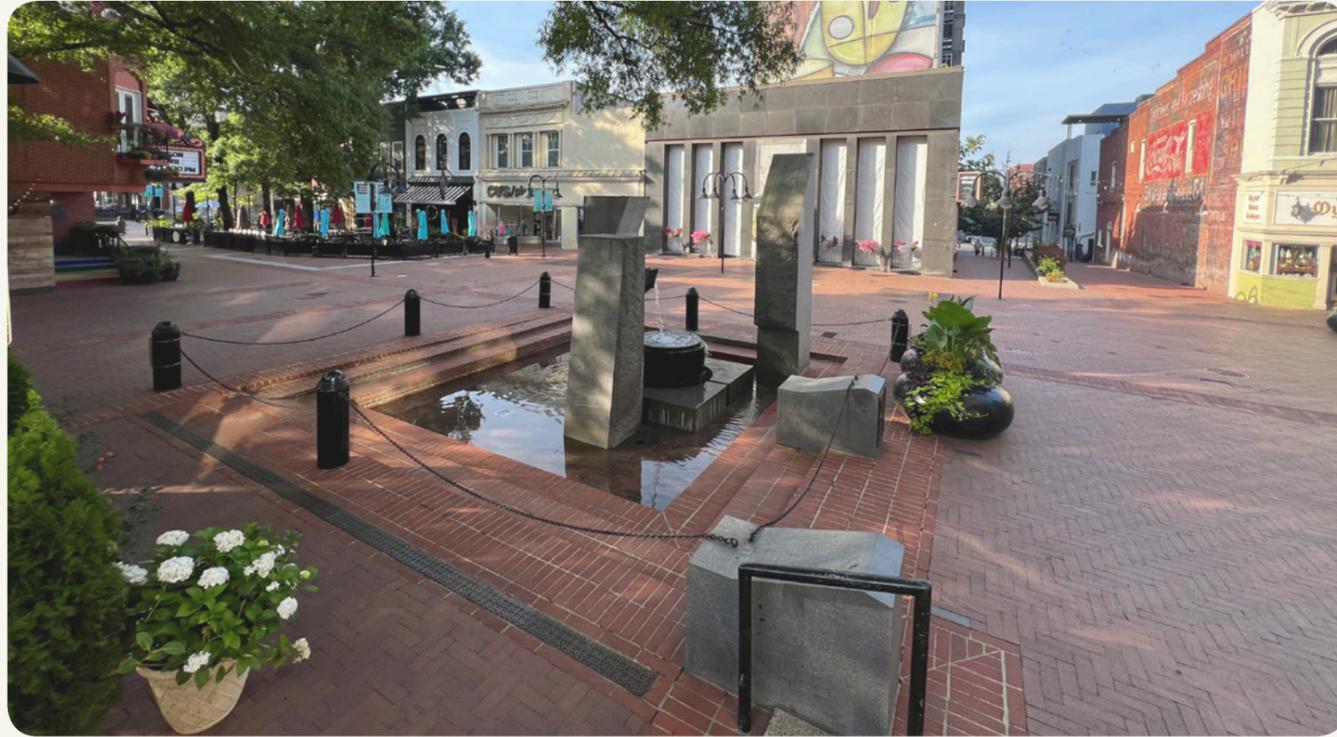
Due to trip hazard concerns, the large cascading fountain at Central Place and the three smaller spring fountains along the Mall have been fenced off, limiting pedestrian interaction and summer water play.

To address this, installing a metal grate surface that allows water to flow through while eliminating the trip hazard is recommended. This would make the fountains accessible again, turning them into lively centers of activity and play instead of unused, fenced-off spaces.

- Remove fencing
- Add metal grate for access

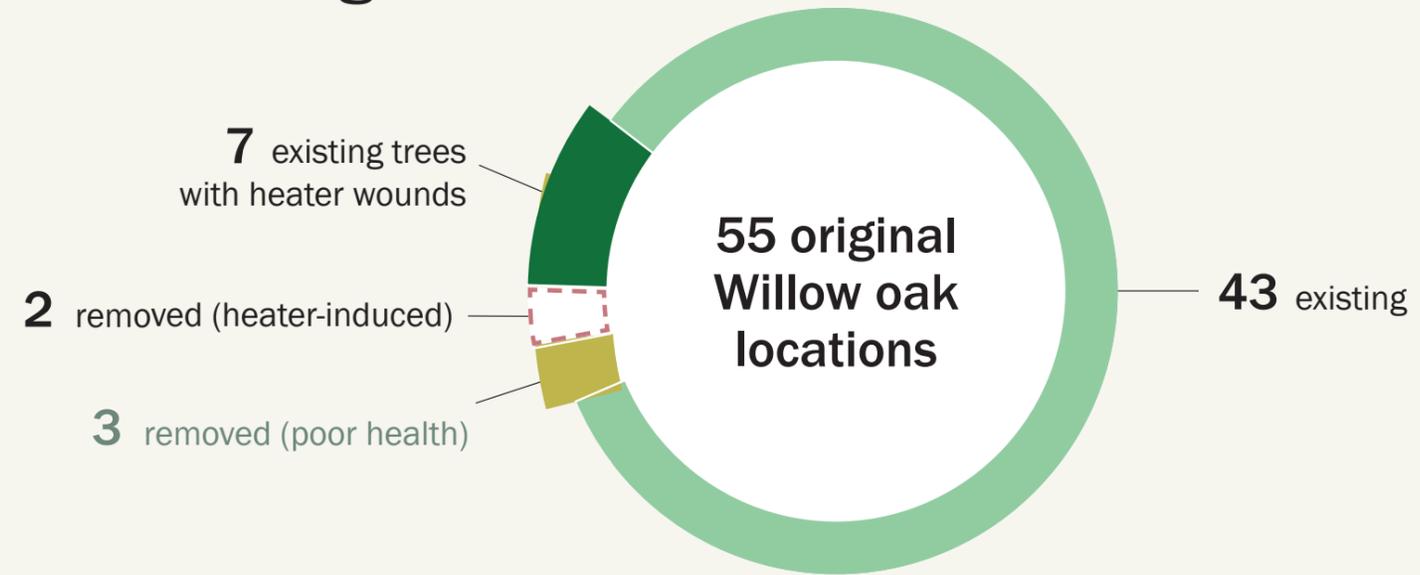
- 9 of 55 original willow oaks were impacted by improper heater use too close to the trees (preventable, human-caused damage)
- 2 of these 9 trees required removal in 2022
- 5 of the 6 cafe enclosures that use heaters near trees have caused the damage
- Light fixtures pose long term health issues to trees and tripping hazard

Since the initial assessment, NDS submitted new heater requirements to all downtown businesses

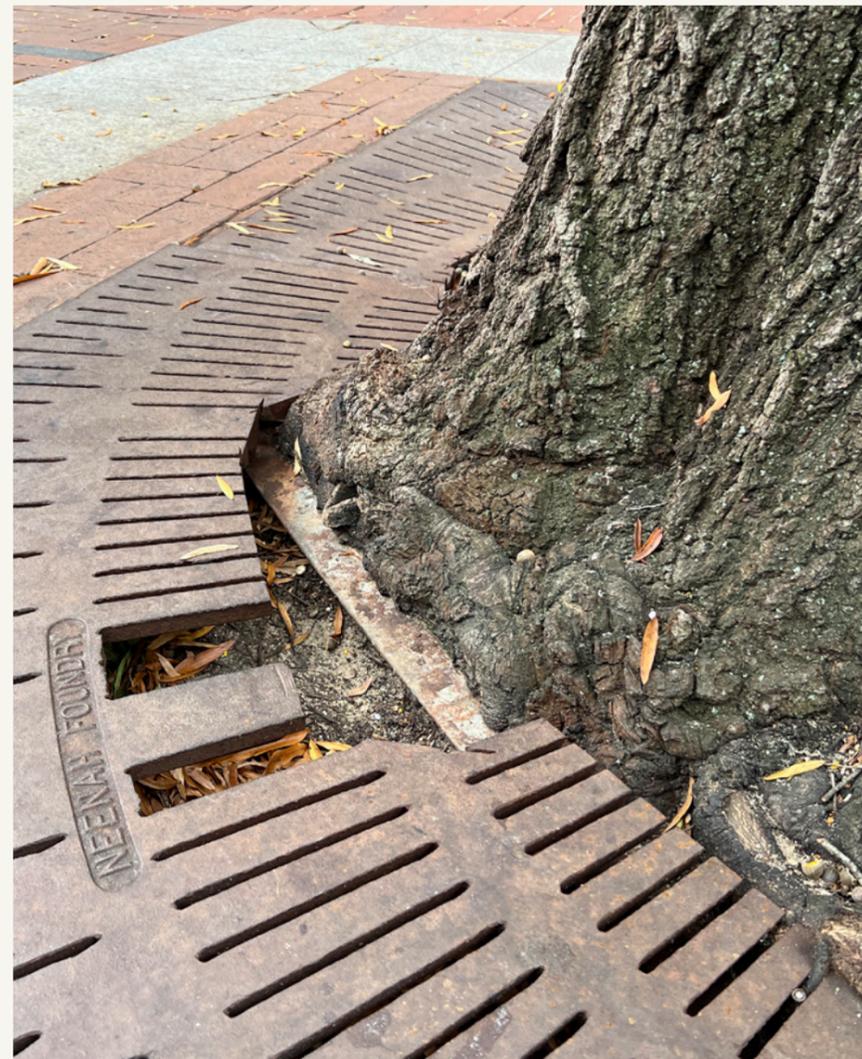
- Tree girdled by grate support beam
- Some trees may be structurally dependent on support beams

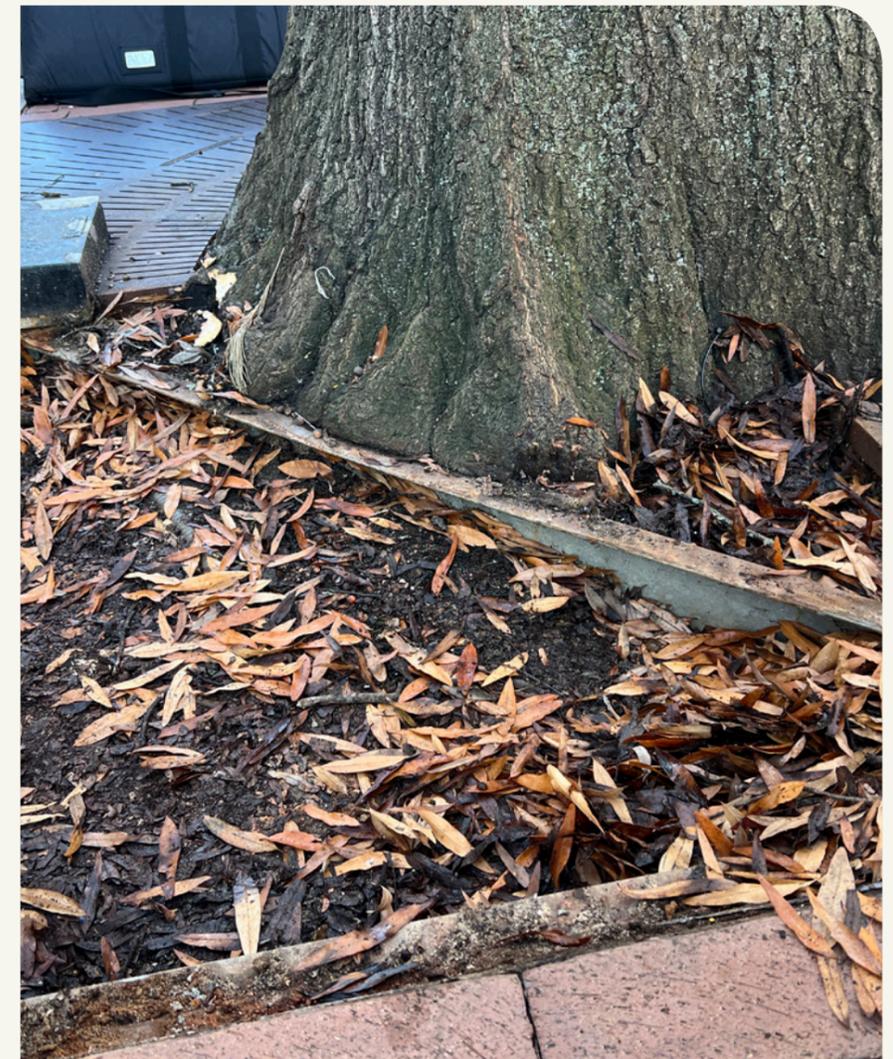
Tree #14

- Visible damage to trunk from grate maintenance
- Root flare girdled by both surface grate and structural grate support
- Grate not designed for expansion with broken "teeth" / trip hazard

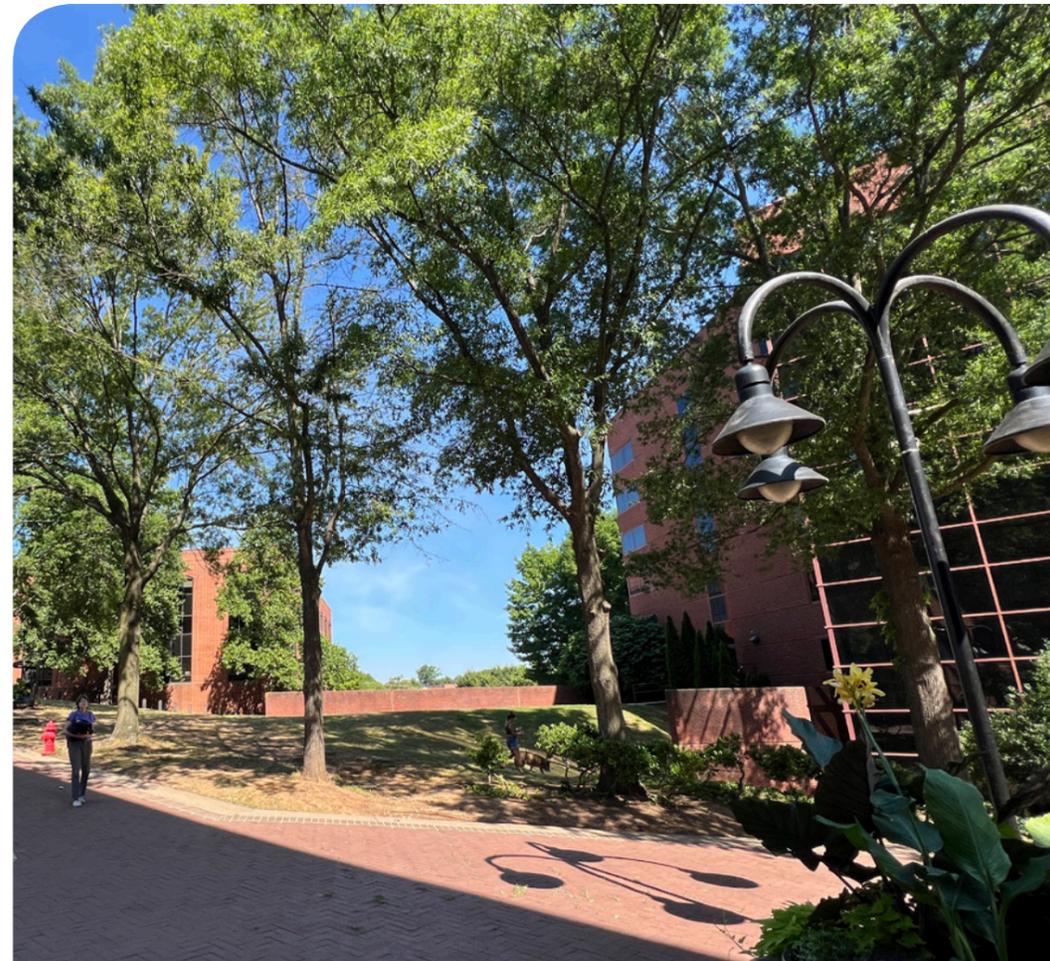
CANOPY CROWDING

- Selectively prune and thin trees to reduce crown competition and building conflicts
- Trees are generally healthy

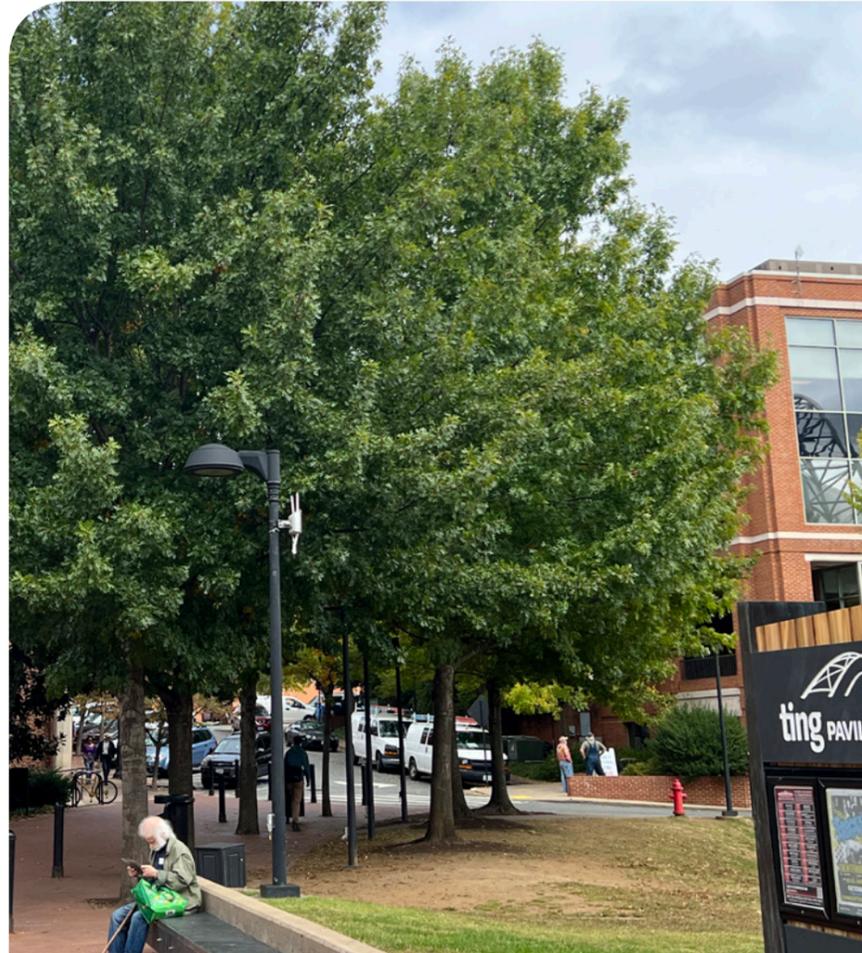
COMPACTED/POOR SOILS

- Heavy surface compaction from events limits water infiltration into soils
- Existing soils have poor nutrient holding capacity leading to greater water stress during droughts. Mulch root zones within lawn areas to better maintain soil moisture.

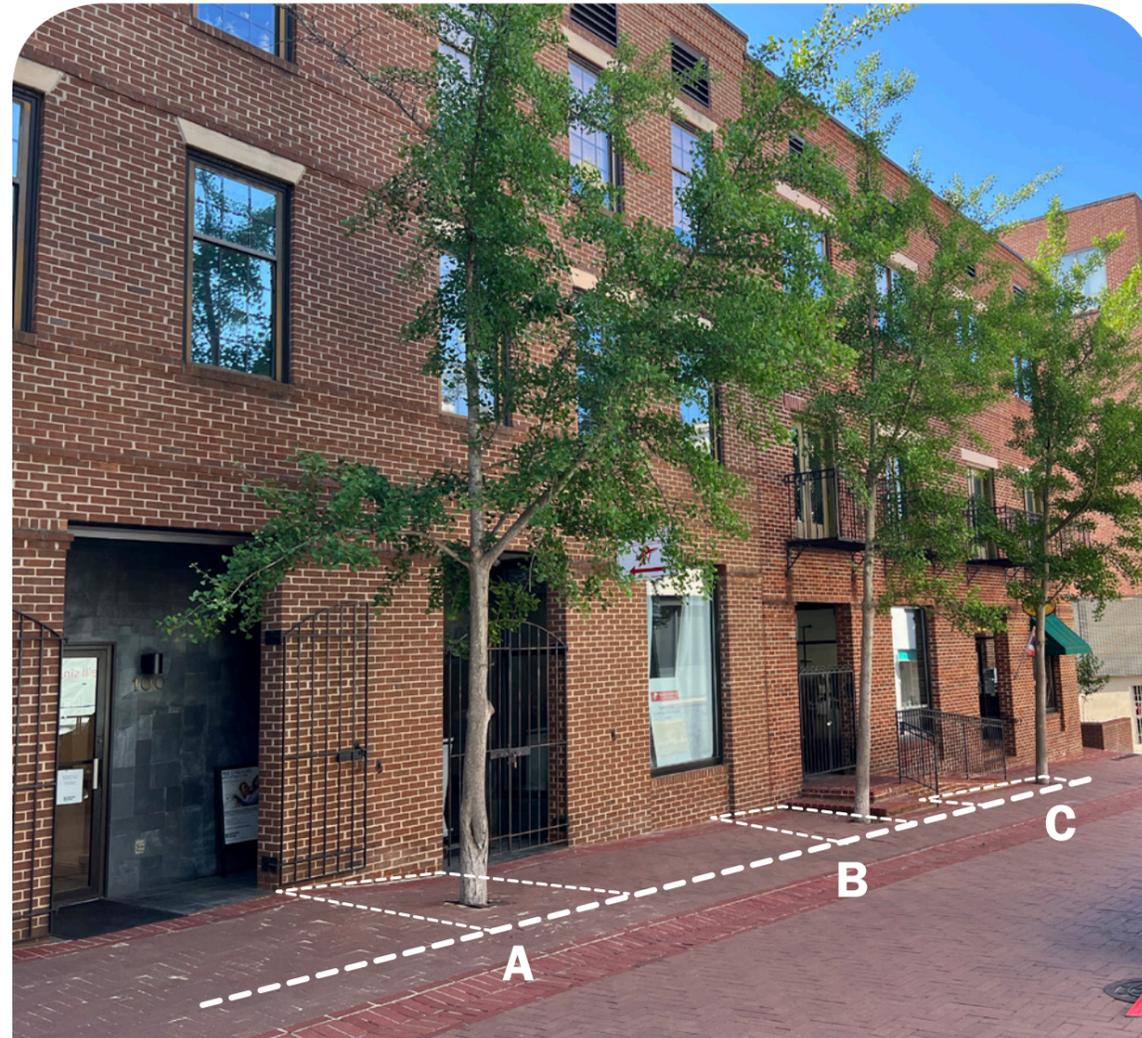
LIMITED SOIL VOLUME

- Trees along 5th St SE have trunk damage due to grate conflicts. At minimum, provide expansion of hidden grate opening (yellow).
