Schenks Branch Tributary Stream Restoration

Project Summary

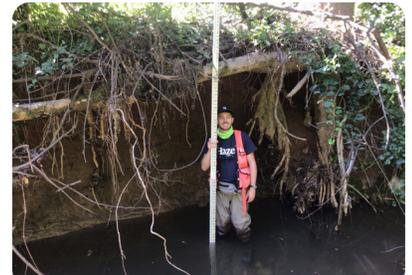
Before

As part of Charlottesville's natural stormwater conveyance infrastructure, Schenks Branch Tributary has an important role in stormwater runoff management and water resources protection. Prior to restoration, some of the unstable and eroding stream banks were as high as 12 feet tall and data collected indicated that 436,000 pounds of sediment was eroding from the stream every year. This severe erosion was causing significant downstream pollution, negatively impacting ecological function, and harming the surrounding habitat of plant and animal species. The project was designed to help reduce pollution, increase ecological function, improve habitat, promote educational opportunities, and provide better public access to the area.

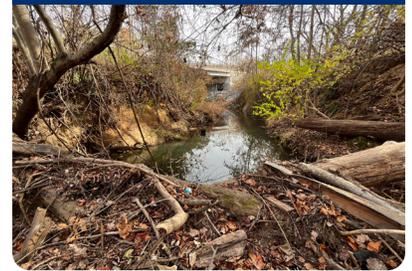
Restoration took six months to complete, from the fall of 2023 to the spring of 2024. The Schenks Branch Tributary design aimed to emulate natural, stable river systems. The design included features such as riffles, pools, cross vanes, j-hook vanes, toe wood, soil lifts, and a rock cascade. These features serve to reduce stream

energy by slowing down and redirecting stream flow, and minimizing erosion and sedimentation while also providing habitat for insects and fish. Construction involved grading the steep banks of the stream, raising the stream bed and connecting it to a new floodplain, and realigning the stream into a more stable pattern. The work necessitated the removal of the existing vegetation and trees along the stream, but many of the trees were being undermined by the eroding stream banks and invasive plant species were prevalent. The City and BGP developed a revegetation plan that resulted in the planting of over 1,400 new native trees, shrubs, and herbaceous plants.
