Charlottesville Downtown Mall **TREE MANAGEMENT PLAN**

APPENDICES F-I

2024

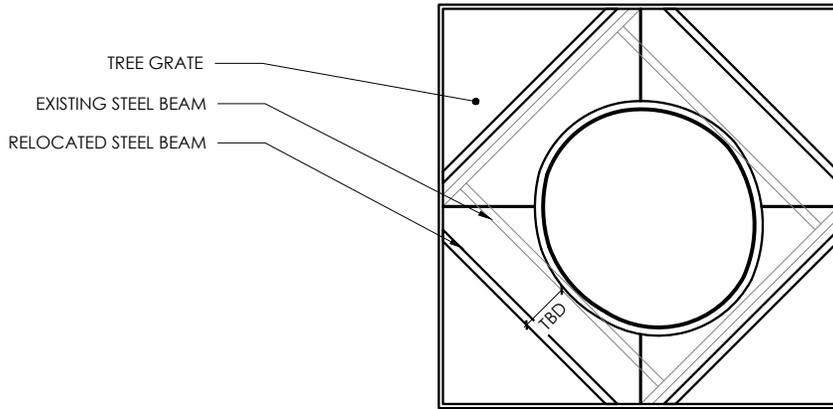
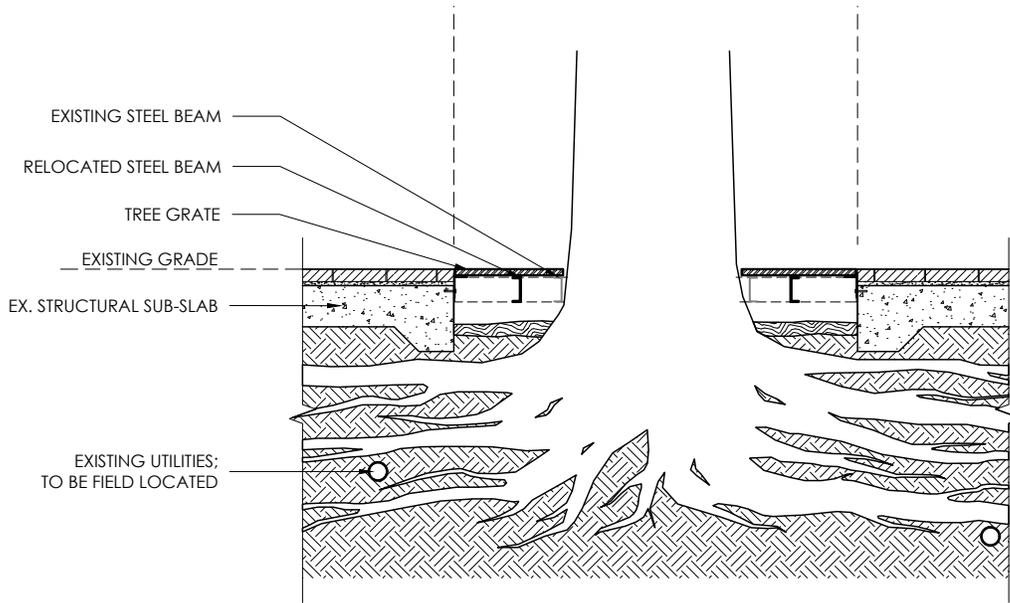
Tree Grate Modification

PLAN

SECTION

NOTE: RELOCATE STEEL BEAM TO MAXIMUM ALLOWABLE DISTANCE FROM TREE TRUNK. STEEL MODIFICATION TO BE REVIEWED BY STRUCTURAL ENGINEER

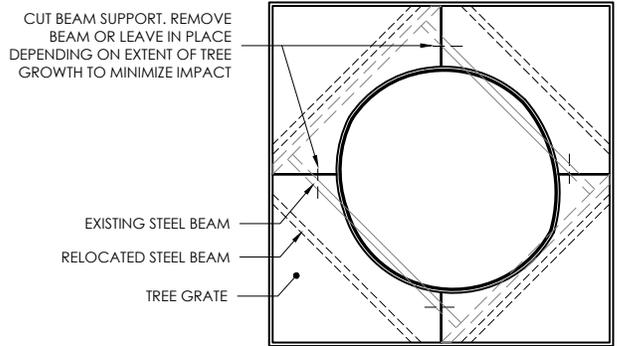
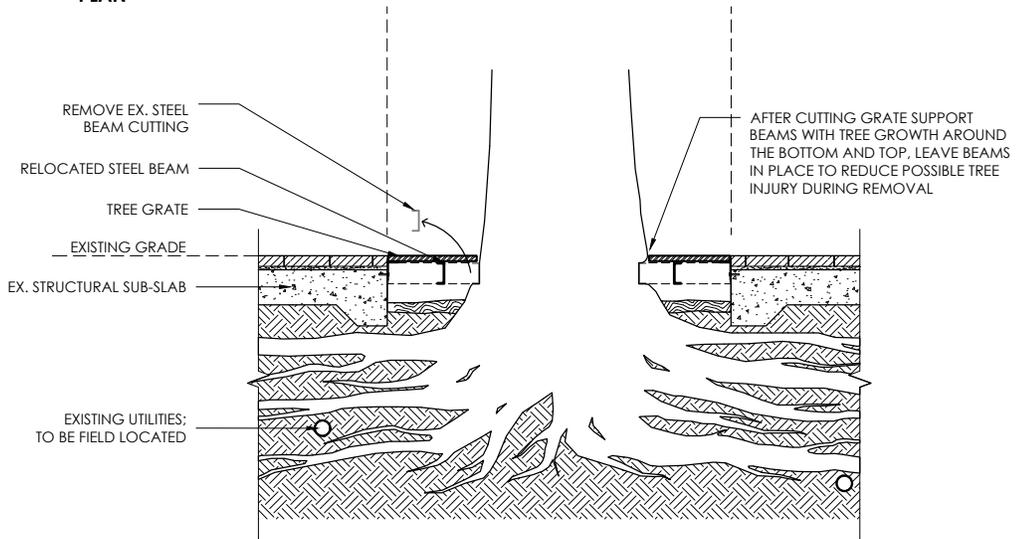
Tree Grate Modification (Girdling)

PLAN

SECTION

NOTE: RELOCATE STEEL BEAM TO MAXIMUM ALLOWABLE DISTANCE FROM TREE TRUNK. STEEL MODIFICATION TO BE REVIEWED BY STRUCTURAL ENGINEER

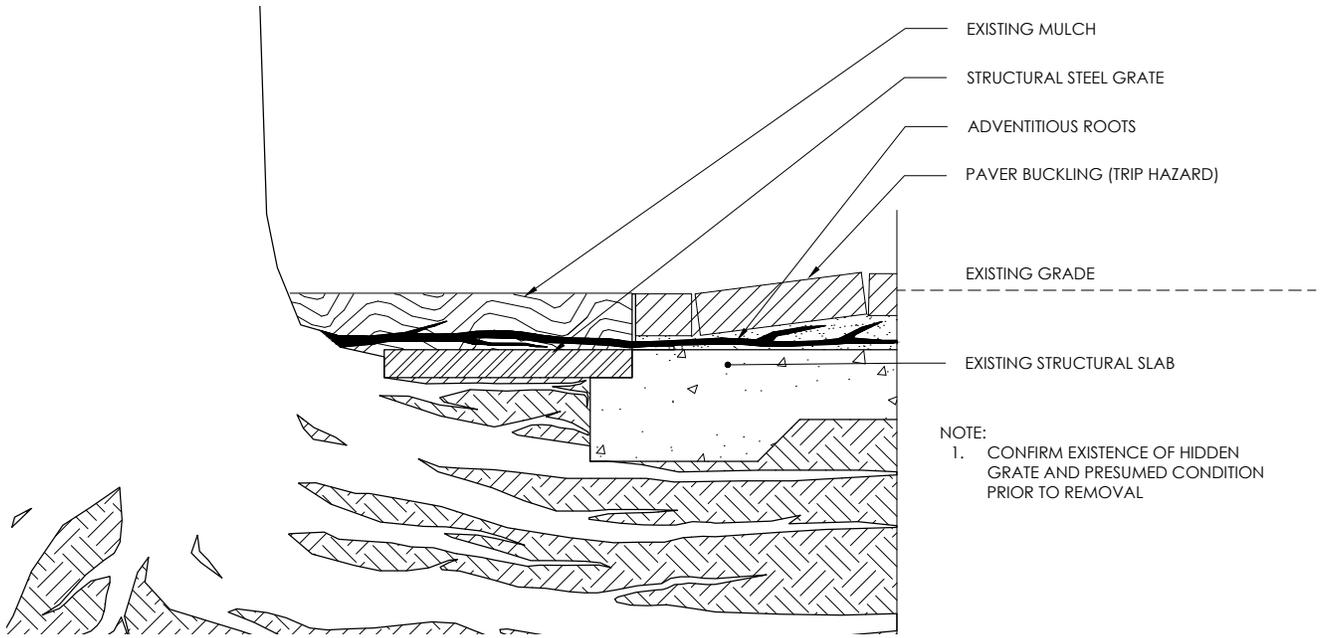
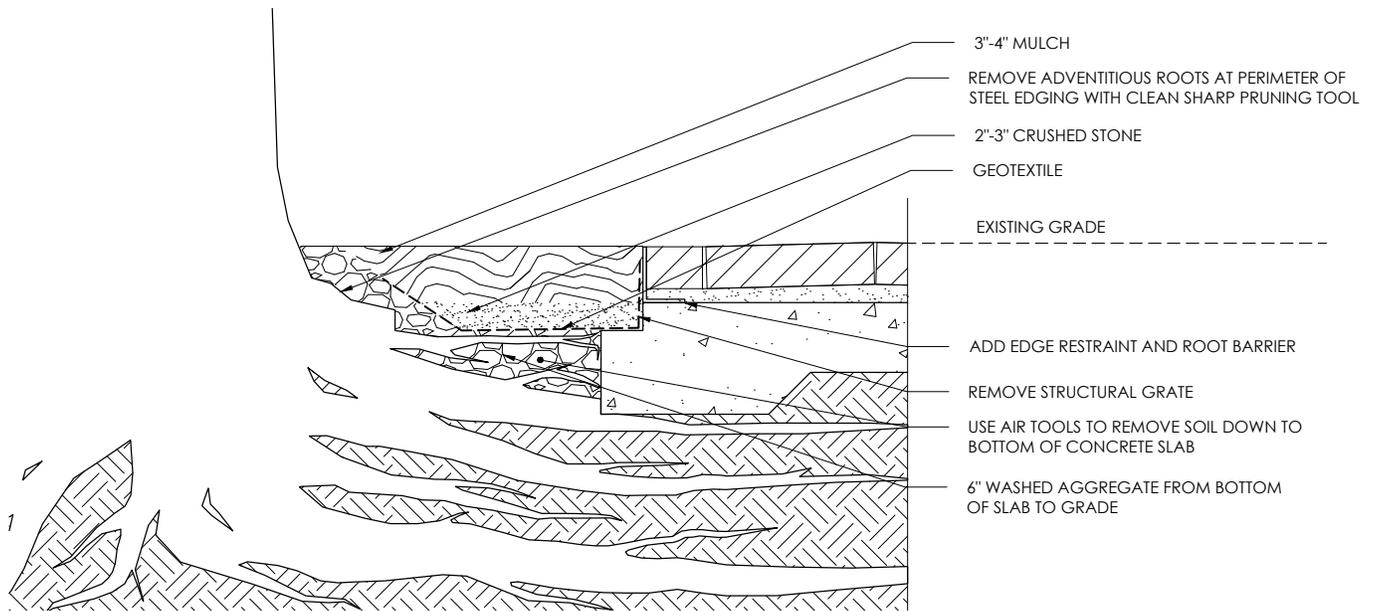
Hidden Tree Grate Removal

Hidden Grate Removal (Assumed Existing Condition)

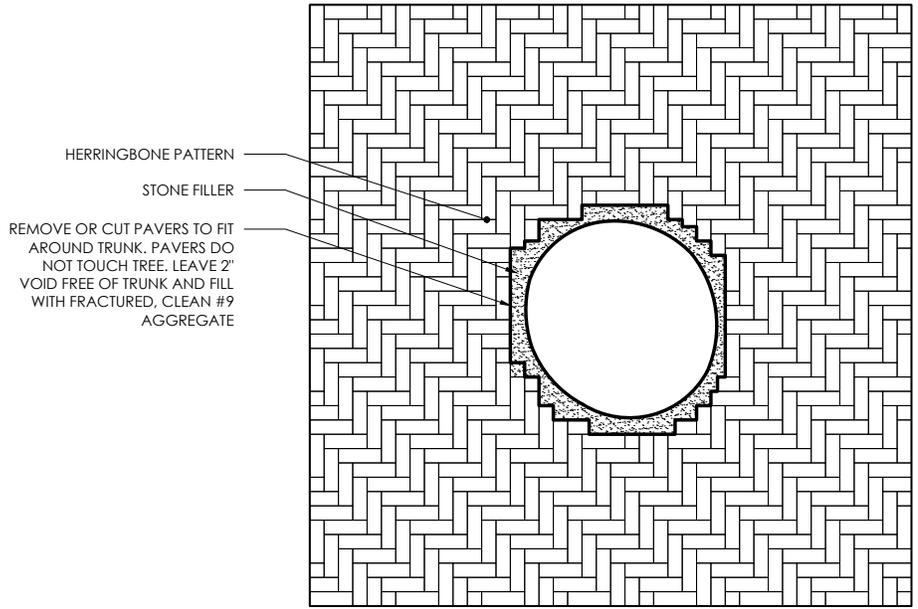
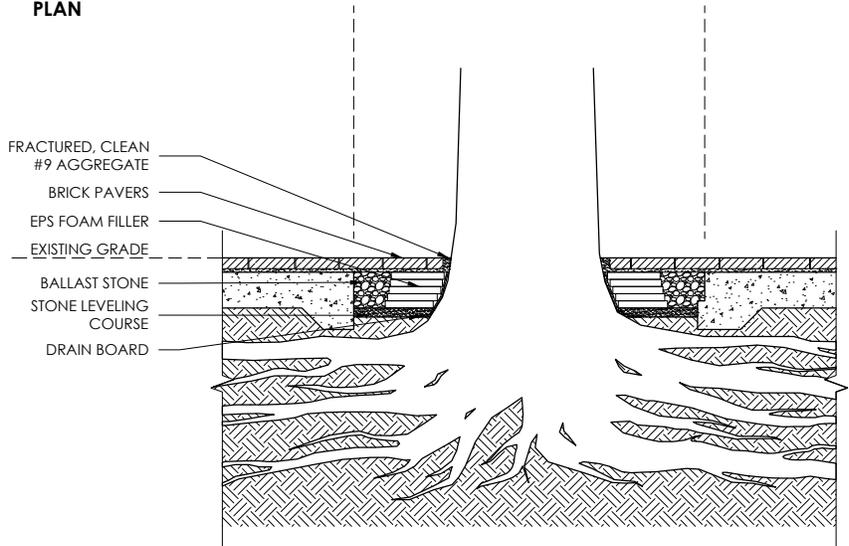
Grate Paver Replacement

PLAN

SECTION

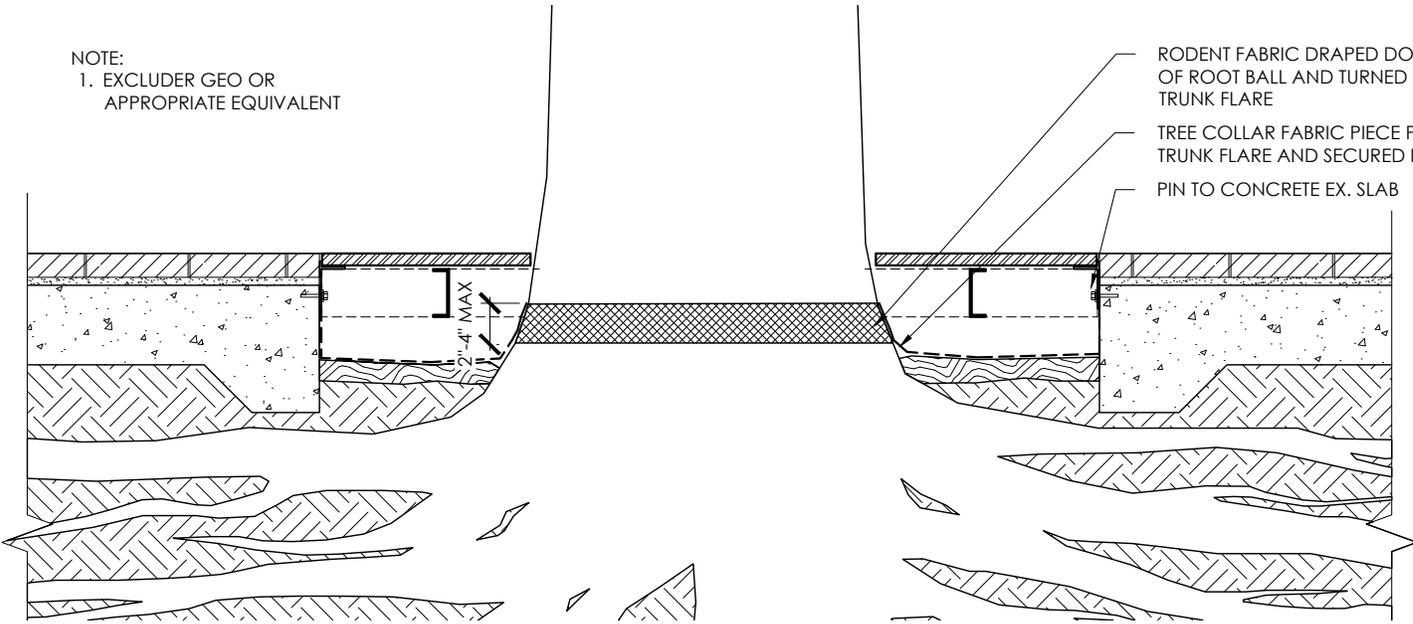
Rodent Barrier (Existing Condition/Grate Modification)

NOTE:
1. EXCLUDER GEO OR
APPROPRIATE EQUIVALENT

RODENT FABRIC DRAPED DOWN OVER TOP
OF ROOT BALL AND TURNED UP TO WRAP
TRUNK FLARE
TREE COLLAR FABRIC PIECE PLACED AROUND
TRUNK FLARE AND SECURED IN PLACE
PIN TO CONCRETE EX. SLAB

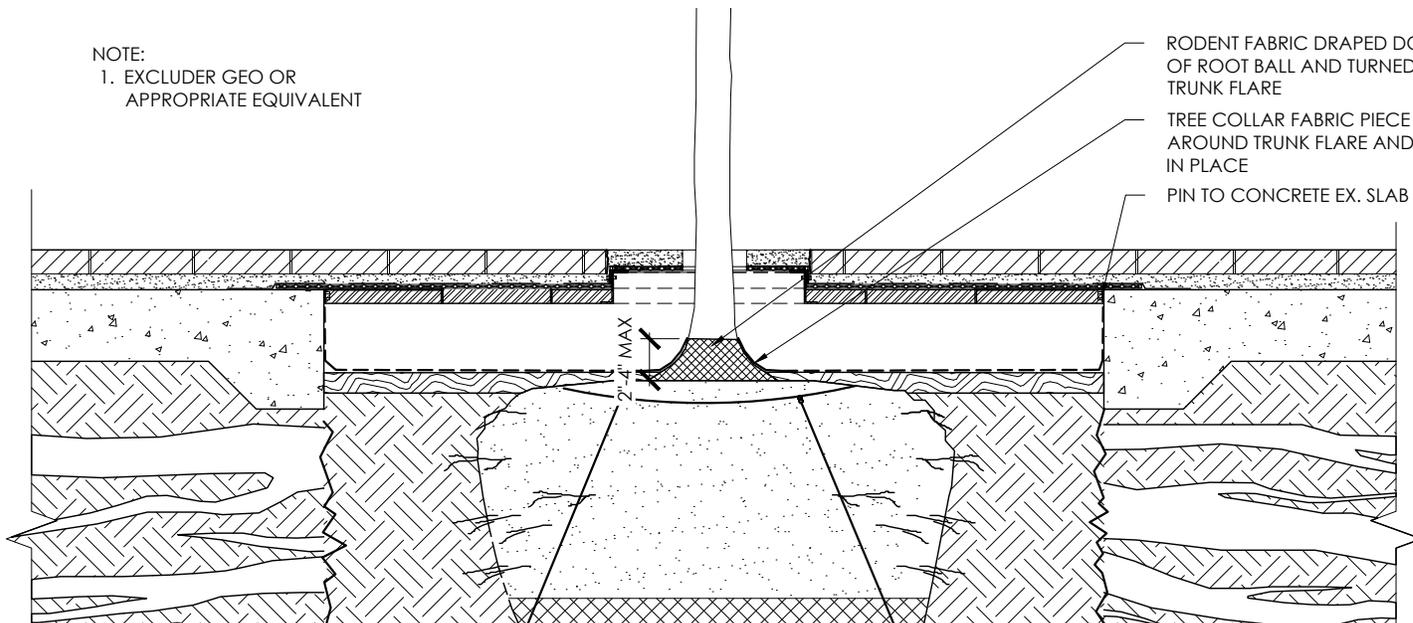
Rodent Barrier (Tree Replacement)

NOTE:
1. EXCLUDER GEO OR
APPROPRIATE EQUIVALENT

RODENT FABRIC DRAPED DOWN OVER TOP
OF ROOT BALL AND TURNED UP TO WRAP
TRUNK FLARE
TREE COLLAR FABRIC PIECE PLACED
AROUND TRUNK FLARE AND SECURED
IN PLACE
PIN TO CONCRETE EX. SLAB

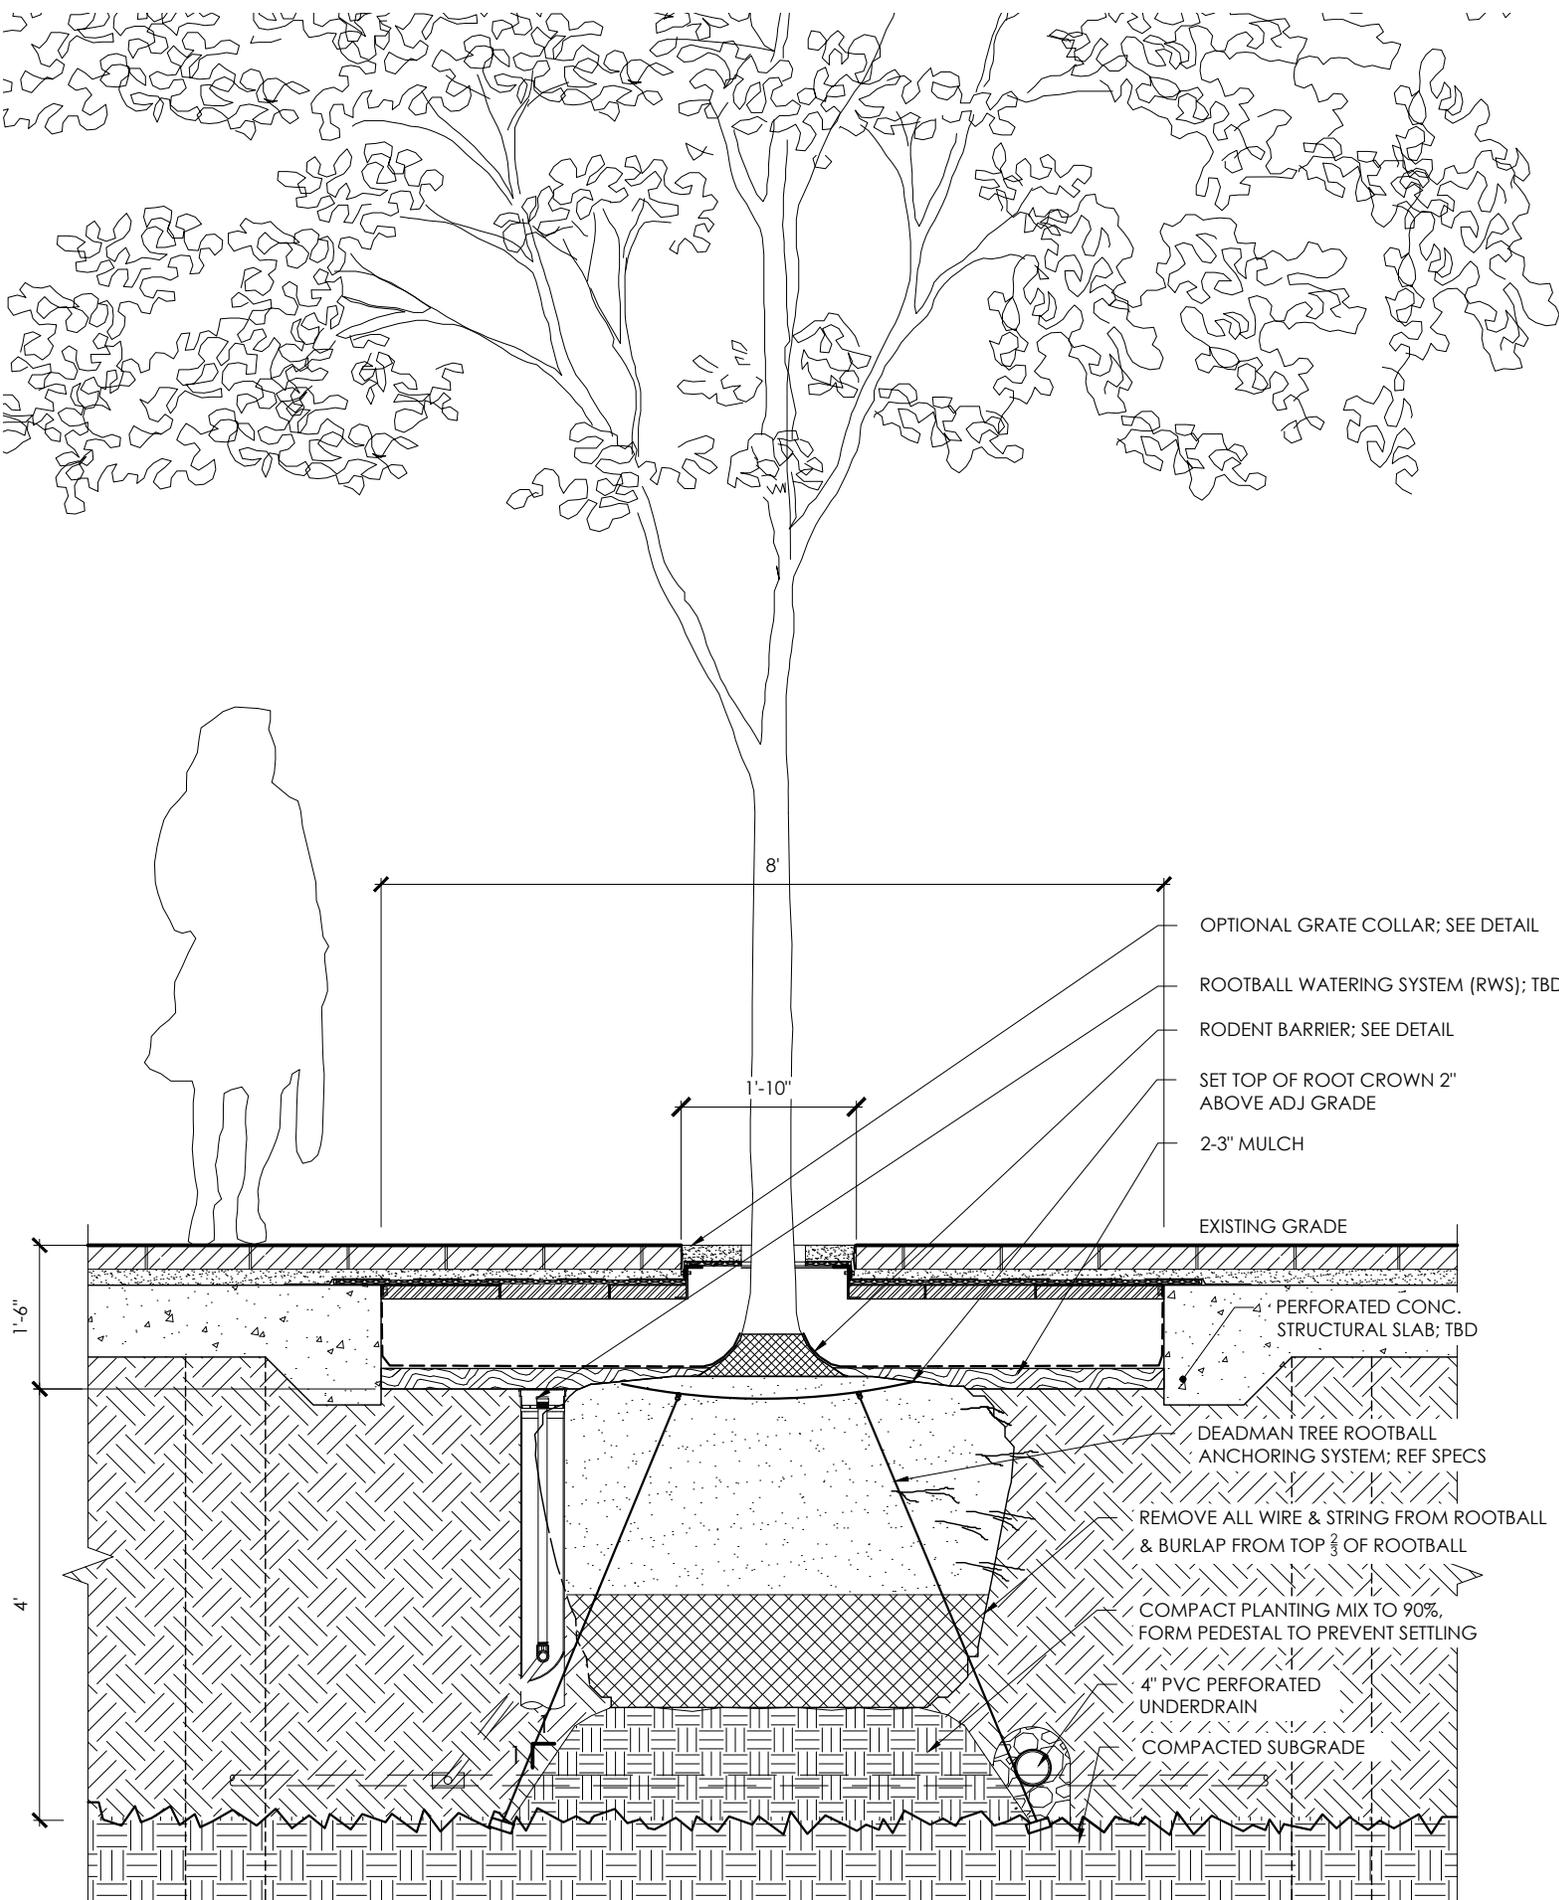
Tree Replacement (Option 2)

- OPTIONAL GRATE COLLAR; SEE DETAIL
- ROOTBALL WATERING SYSTEM (RWS); TBD
- RODENT BARRIER; SEE DETAIL
- SET TOP OF ROOT CROWN 2" ABOVE ADJ GRADE
- 2-3" MULCH
- EXISTING GRADE
- PERFORATED CONC. STRUCTURAL SLAB; TBD
- DEADMAN TREE ROOTBALL ANCHORING SYSTEM; REF SPECS
- REMOVE ALL WIRE & STRING FROM ROOTBALL & BURLAP FROM TOP 2/3 OF ROOTBALL
- COMPACT PLANTING MIX TO 90%, FORM PEDESTAL TO PREVENT SETTLING
- 4" PVC PERFORATED UNDERDRAIN
- COMPACTED SUBGRADE

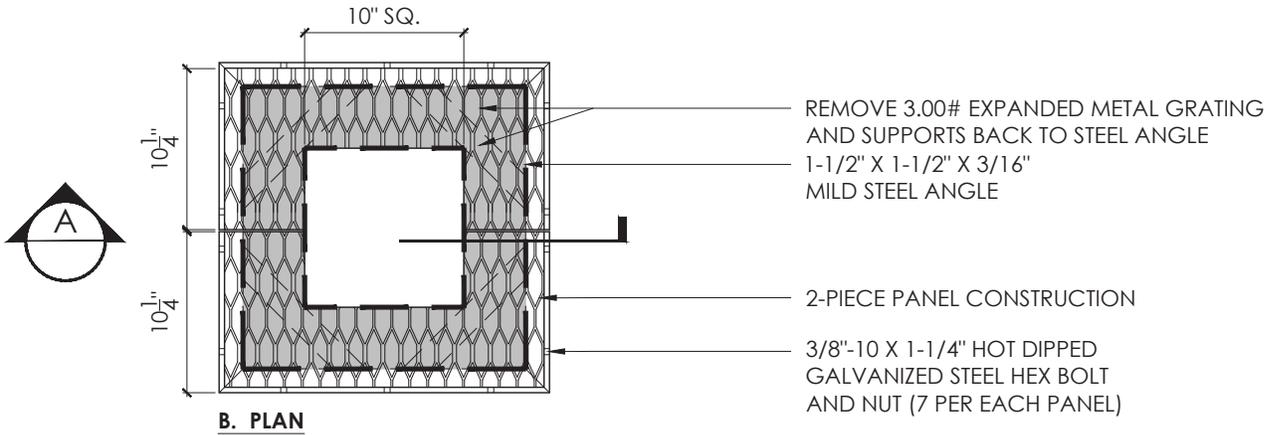
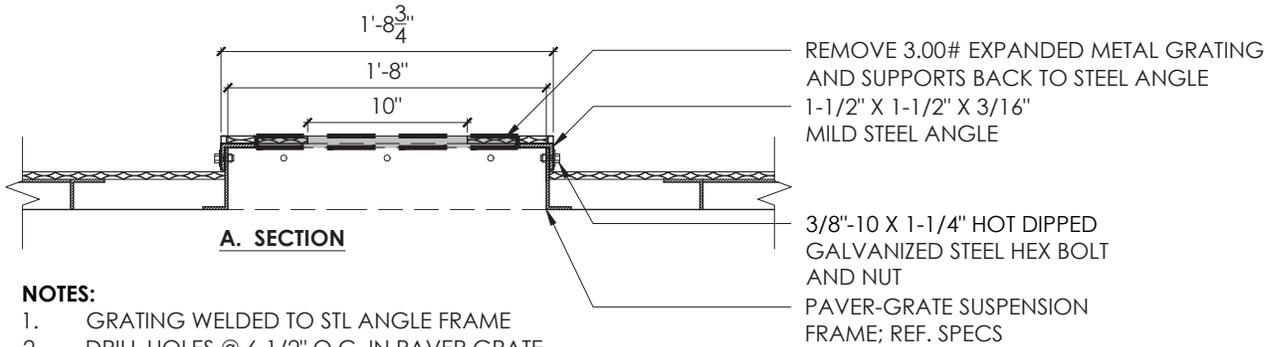
NOTES:

1. GRATING WELDED TO STL ANGLE FRAME
2. DRILL HOLES @ 6-1/2" O.C. IN PAVER GRATE FRAME AT TREE OPENING TURN UP TO ANCHOR CUSTOM COLLAR FRAME

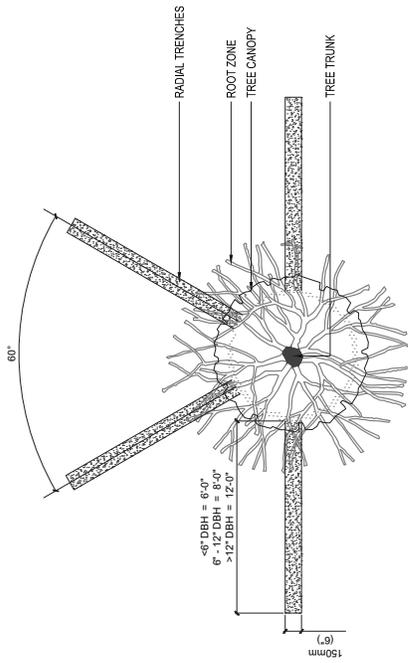
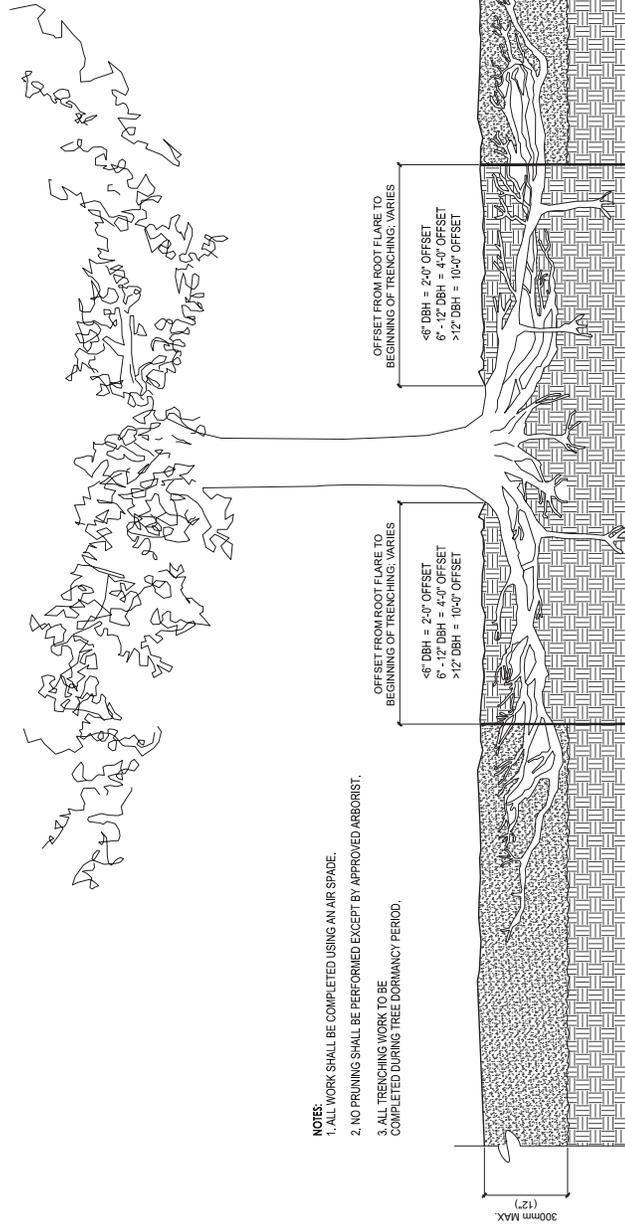
PLAN VIEW: NTS

SECTION VIEW

- NOTES:**
1. ALL WORK SHALL BE COMPLETED USING AN AIR SPADE.
 2. NO PRUNING SHALL BE PERFORMED EXCEPT BY APPROVED ARBORIST.
 3. ALL TRENCHING WORK TO BE COMPLETED DURING TREE DORMANCY PERIOD.

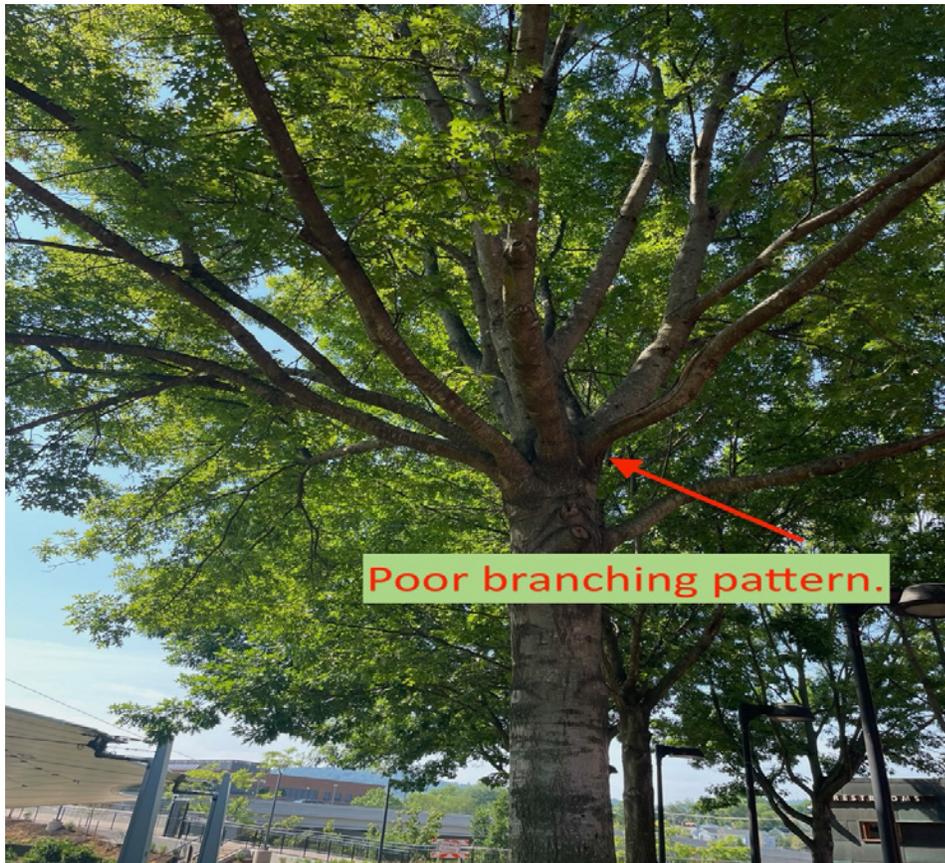
Tree #113

For tree #113, a decision must be made regarding which limbs to retain, and how best to undertake restoration pruning with the least amount of damage. It might be possible to improve the branching structure, but it might involve 10 years of incremental pruning. Early structural pruning would have produced a better tree and saved thousands of dollars of pruning costs.

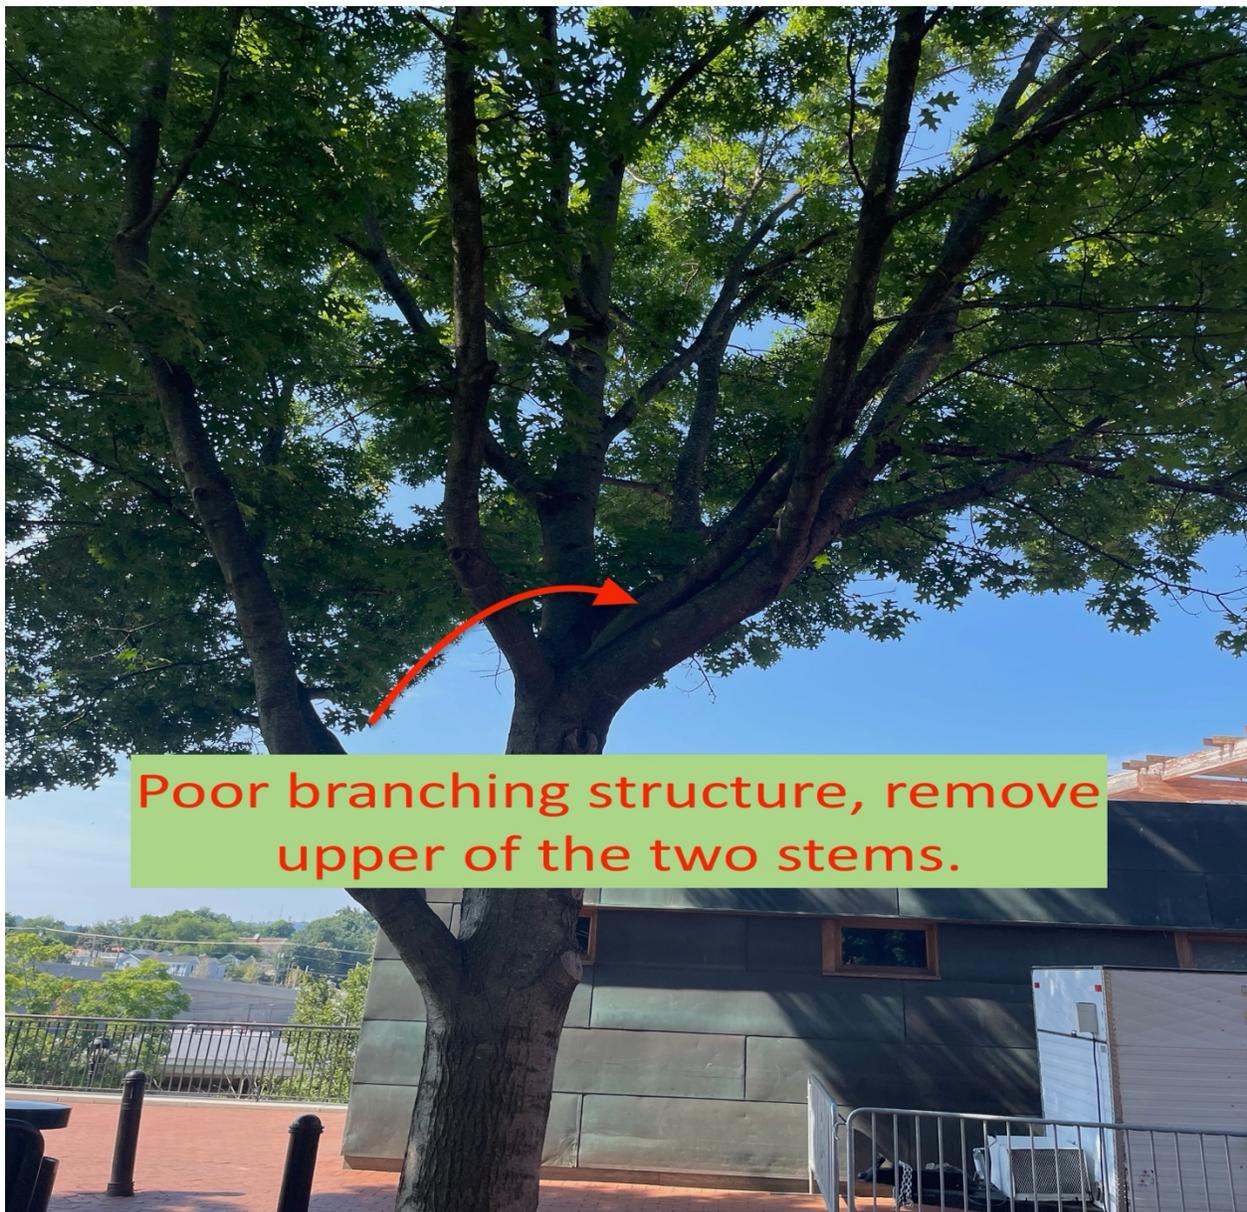
Tree 2C

A similar example is found in tree #2C near the pavilion where two limbs are growing in close proximity. Poor pruning in the nursery led to this defect. Exaggerated weight loading on the trunk from these two limbs makes it more likely that limb failure will occur. Therefore, the upper limb of these two should be incrementally subordinated and removed.

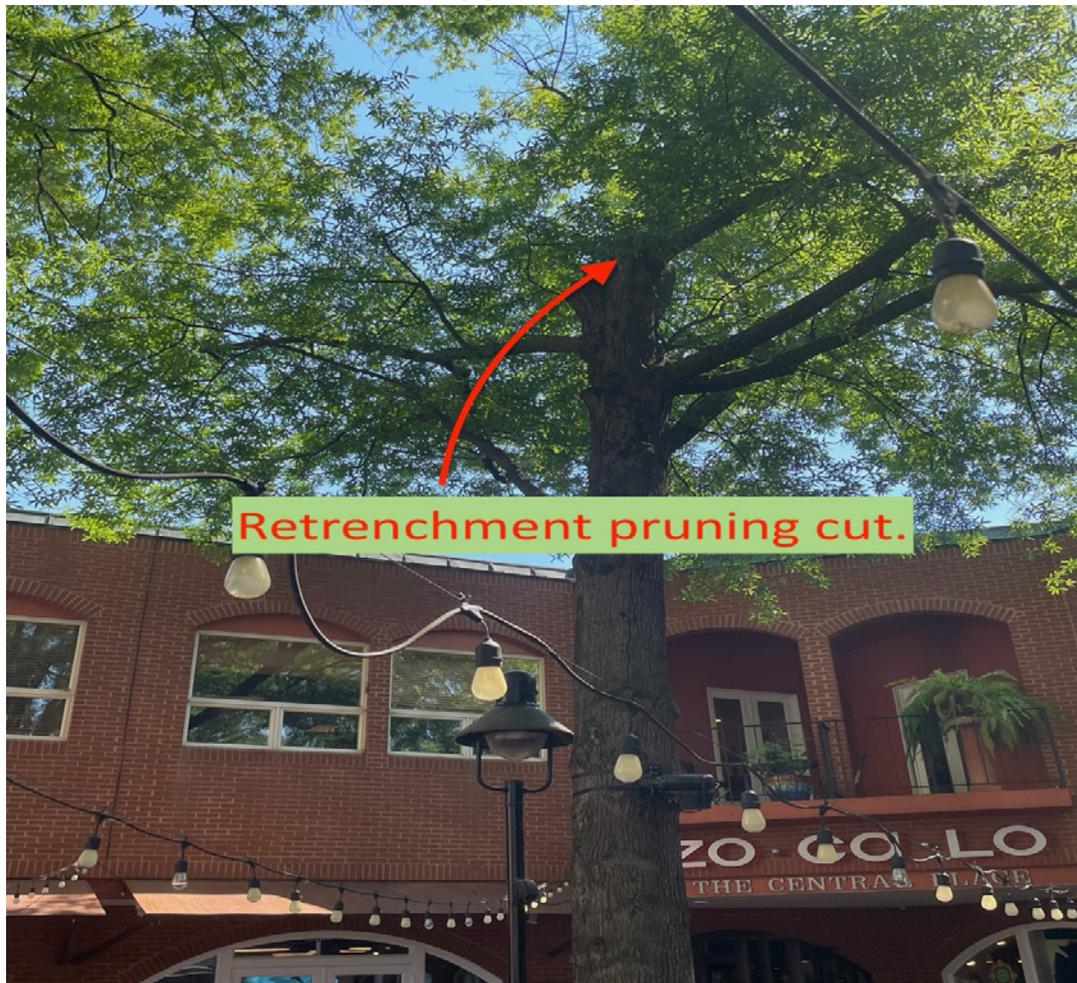
Tree #41 – retrenchment pruning gone wrong.

Tree #41 received a retrenchment pruning treatment many years ago. This may have been an effort to lower the wind profile, or to remove deadwood. Regardless of the objective, the result is considerable dead bark and cambium below this cut. Decay will progress down the main stem and will compromise the structural integrity of the lateral limbs adjacent to this cut. These limbs will need to be monitored for an indication of active failure. It could also fail due to the weight and fall to the ground. This is exactly the type of pruning cut that should be avoided on these mature oaks.

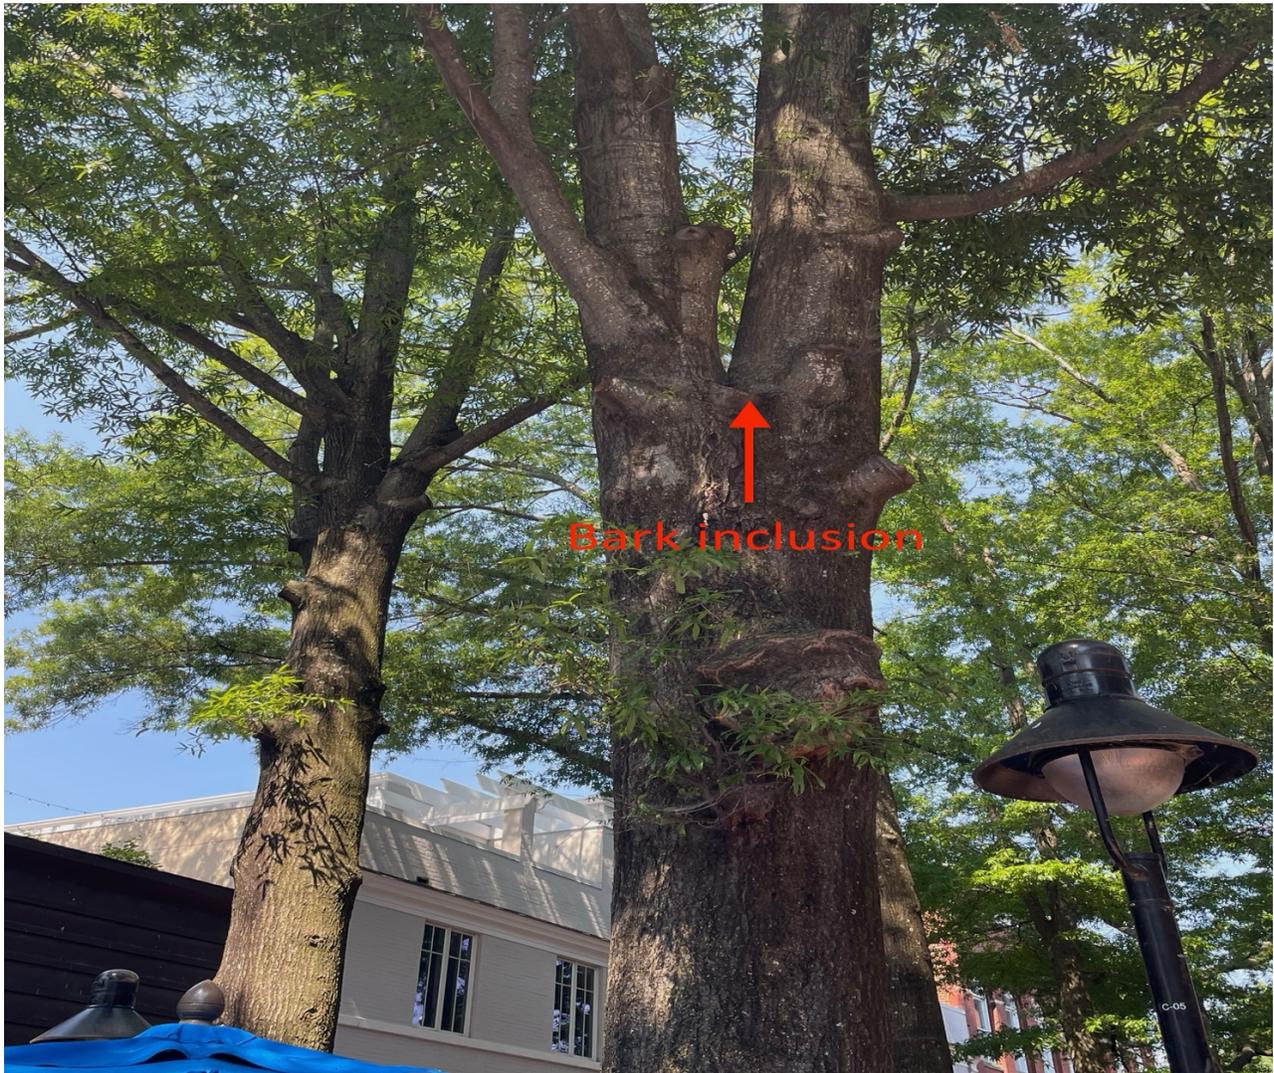
Tree #62 – candidate for structural support system

Tree #62 is an example of where a structural support system of either a bracing rod, or cables should be added to add support to this defect. In this situation, it is preferable to add a support system versus removing live limbs to reduce the weight on these limbs. Too many live limbs would need to be removed to be effective in reducing the risk of this defect. A structural support system is the better option.

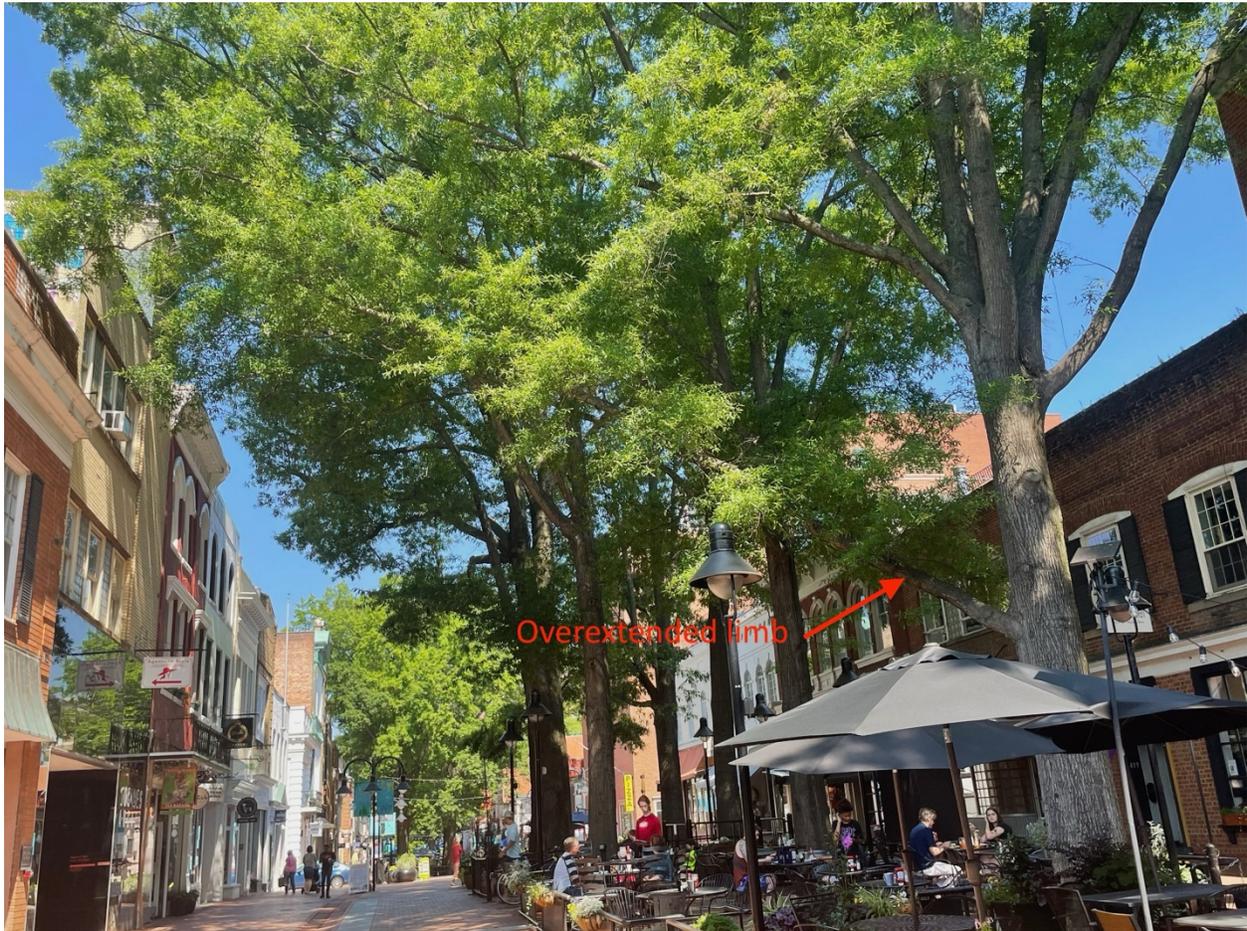
Tree #20 – a candidate for reduction pruning on an overextended limb.

Tree #20 has an overextended limb that could fail in the future. It extends over the building to the left, and a seating area. Because the limb is in good condition, with no indications of any defects and plenty of live limbs along its length, this would be a good candidate for incremental reduction pruning.

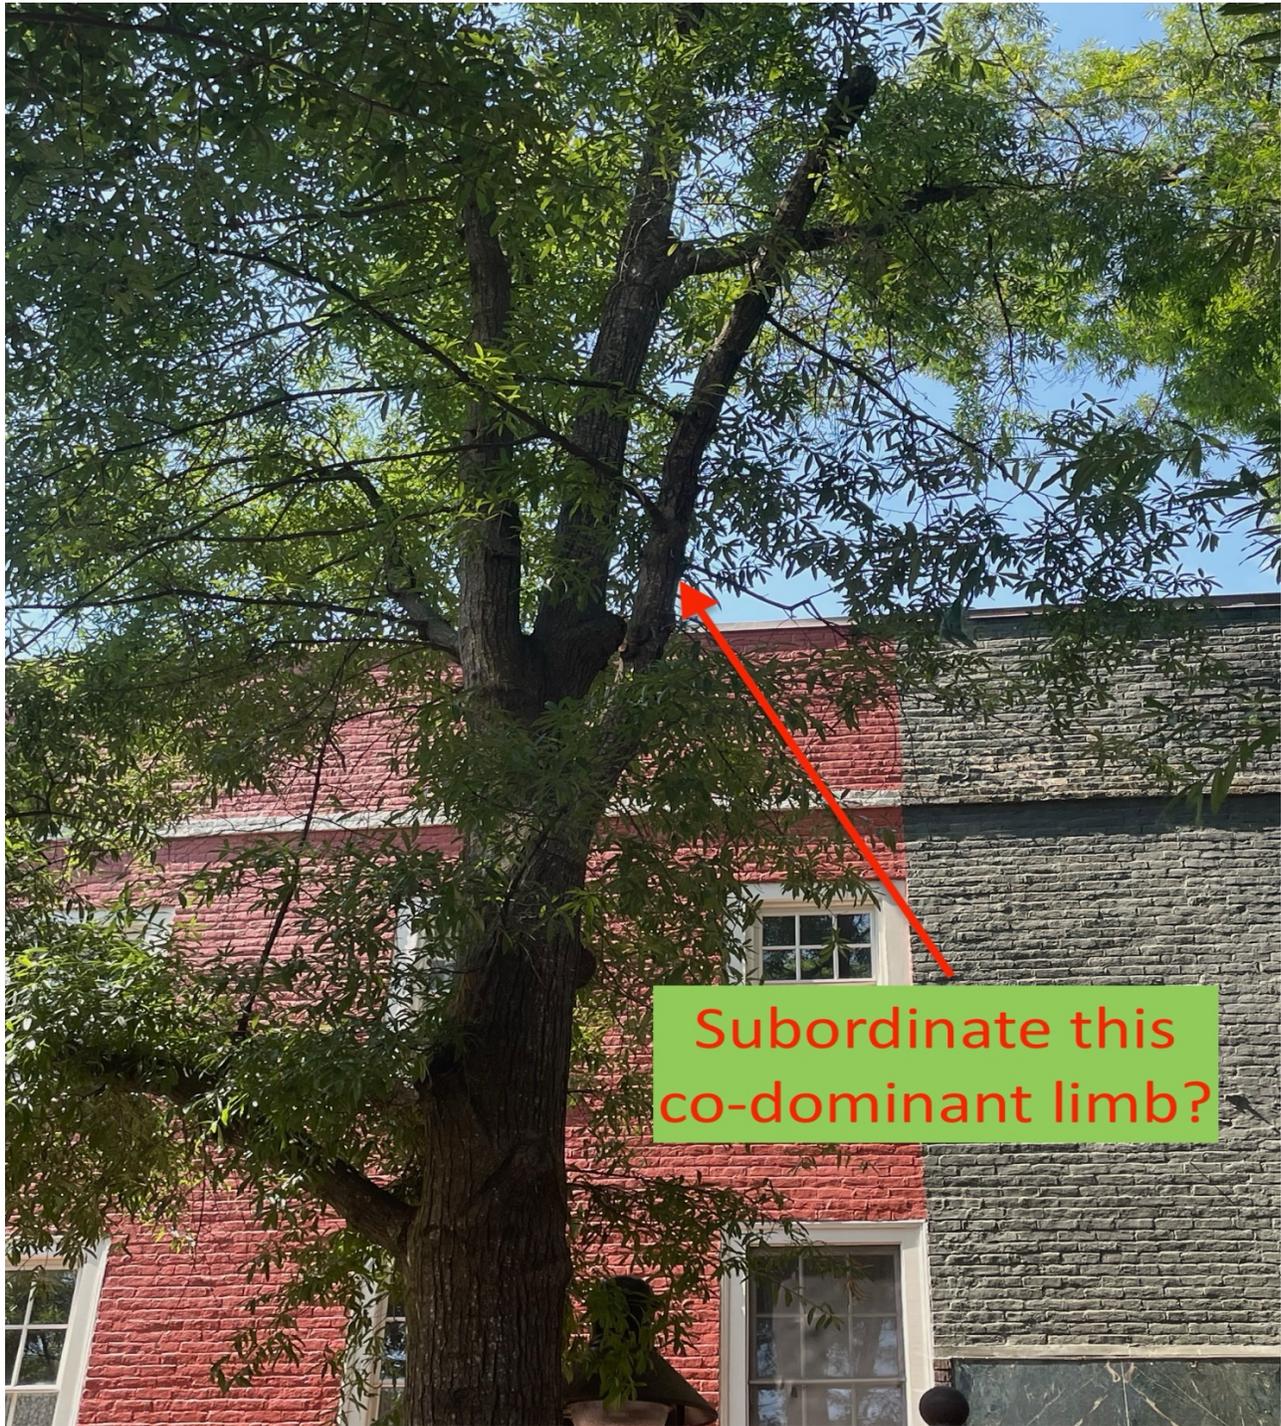
Tree #33 – another candidate for reduction pruning, or subordination.

This limb in tree #33 has been poorly pruned. This is a heading cut that is detrimental to the tree. It is probably best to prune the limb back to the branch collar at the trunk and accept that there would be a wound larger than is desired but understand that we are eliminating a co-dominant stem.

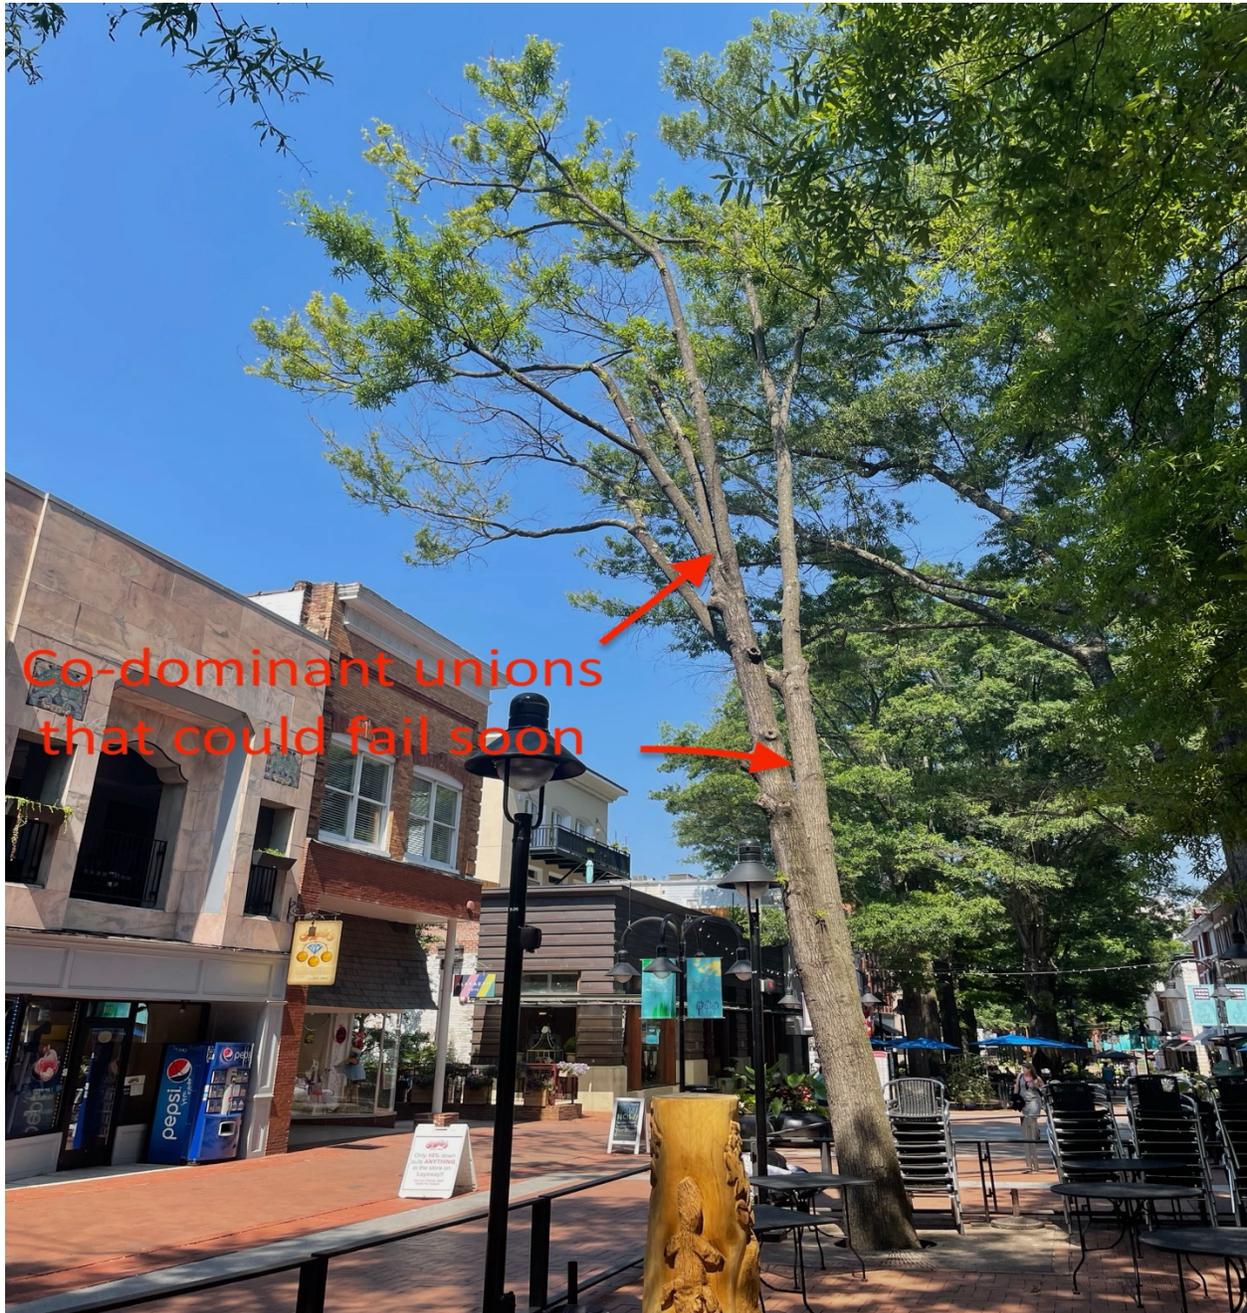
Tree #59 - a candidate for removal due to dieback and dangerous branch unions.

This tree is declining in vigor rapidly as evidenced by the extensive amounts of dead wood. What is most concerning is the occurrence of two areas of bark inclusion. Due to the lean of this tree, the weight of the limbs and bark inclusions, this tree could fail in multiple locations at any time.

Some trees are in such an advanced stage of decline that trying to retain them seems futile. They may also represent an unacceptable level of risk. Trees #54 and 59 are in this condition now and should be considered for removal.

Several trees have been identified as removal candidates. Trees #54 and 59 are examples of trees that should be removed in the near future. The limbs of these trees represent a moderate to high level of risk for failure.
