Charlottesville Downtown Mall **TREE MANAGEMENT PLAN**

RECOMMENDATIONS + APPENDICES

2024

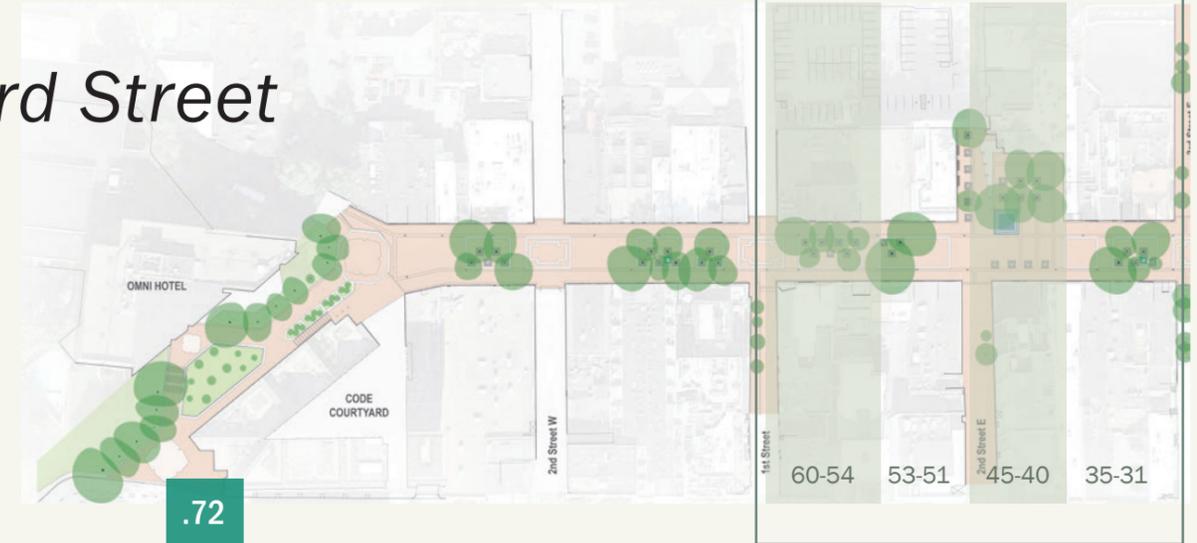
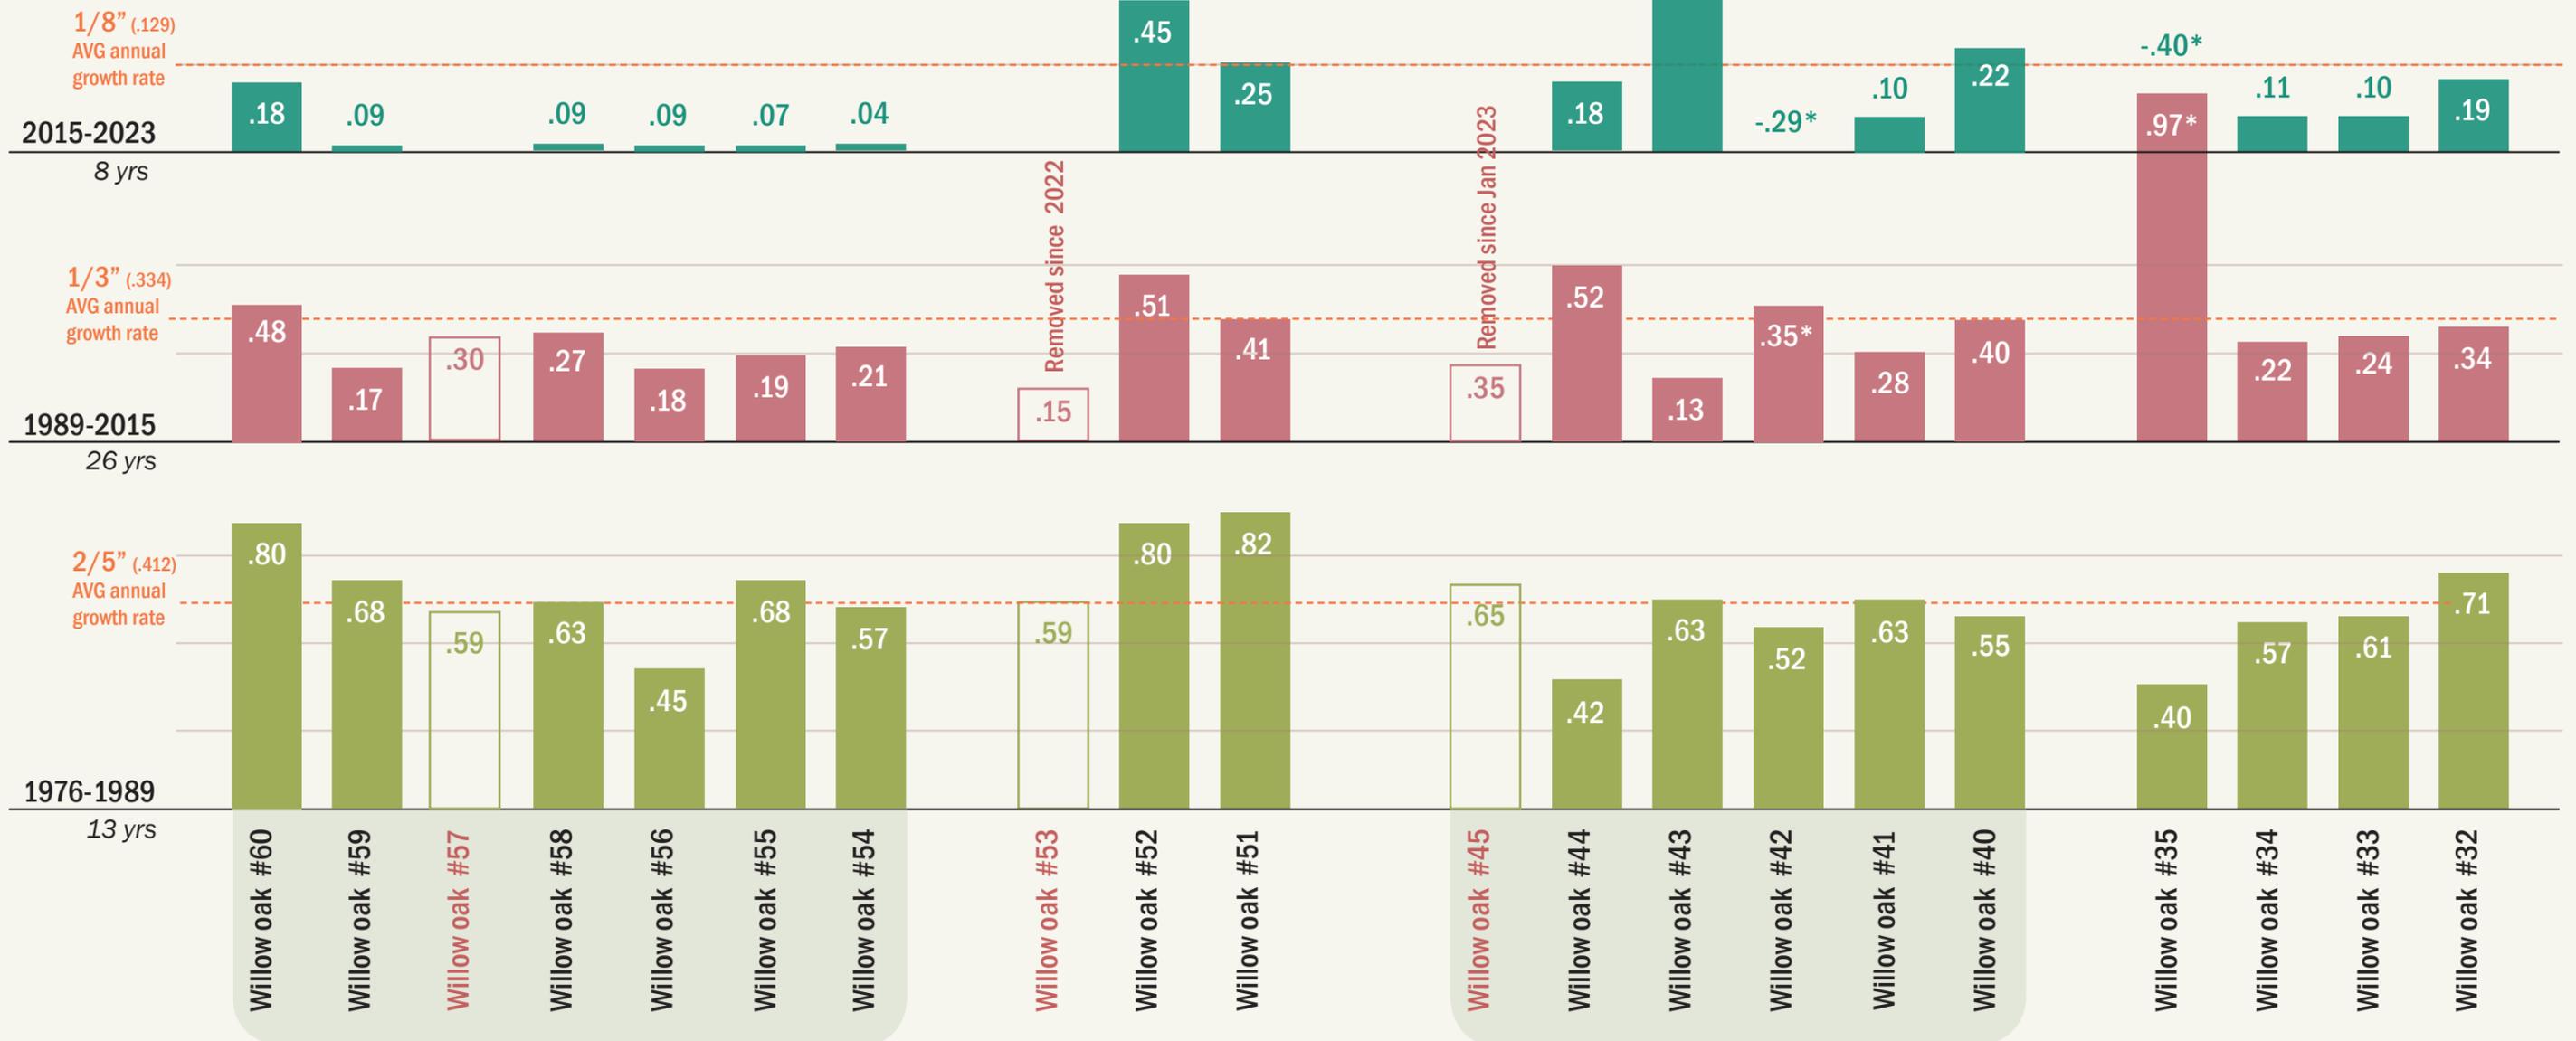
Above Ground | Willow Oak Vigor: West of 3rd Street

47 years of tree data (started in 1976)

- DBH measurements taken in 1976, 1989, 2015, 2023
- Data reveals reduced growth rate of internal grove trees
- Three tree groves show improved growth
- Growth rates decline over time

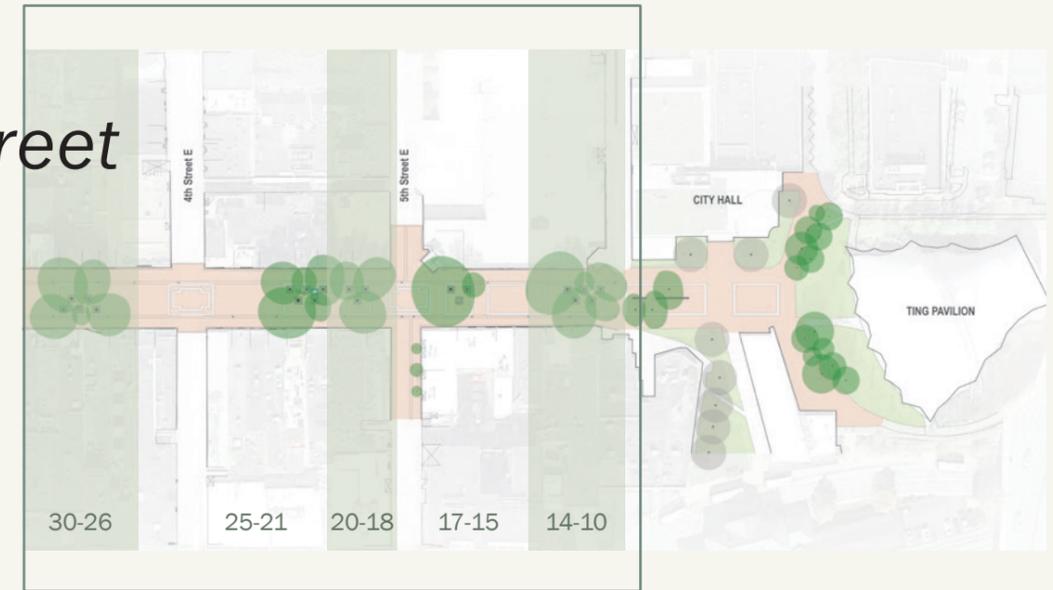
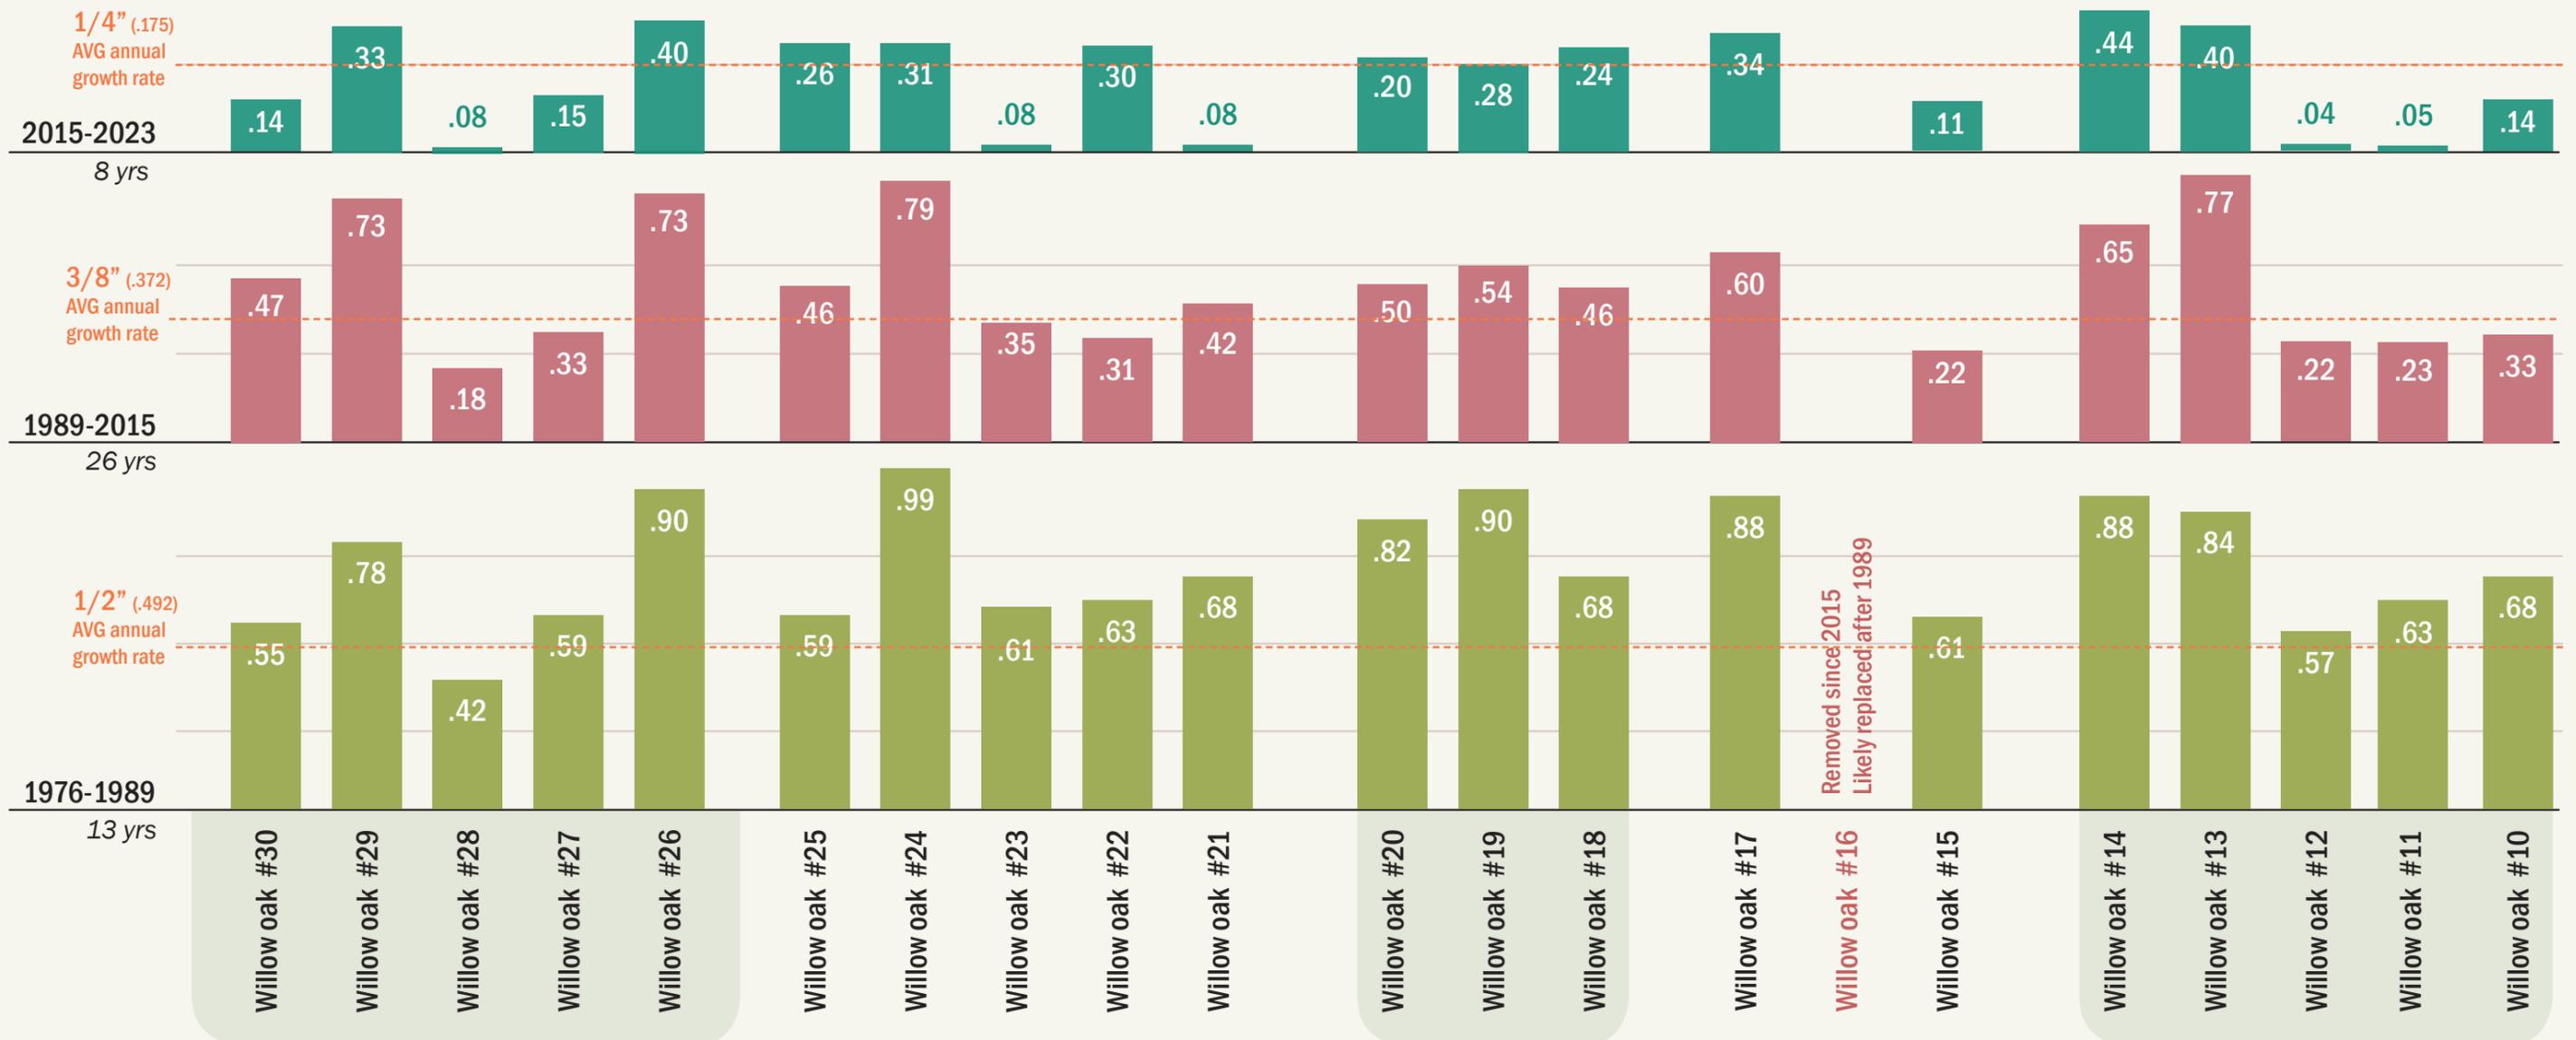
Above Ground | Willow Oak Vigor: East of 3rd Street

47 years of tree data (started in 1976)

- DBH measurements taken in 1976, 1989, 2015, 2023
- Data reveals reduced growth rate of internal grove trees
- Three tree groves show improved growth
- Growth rates decline over time

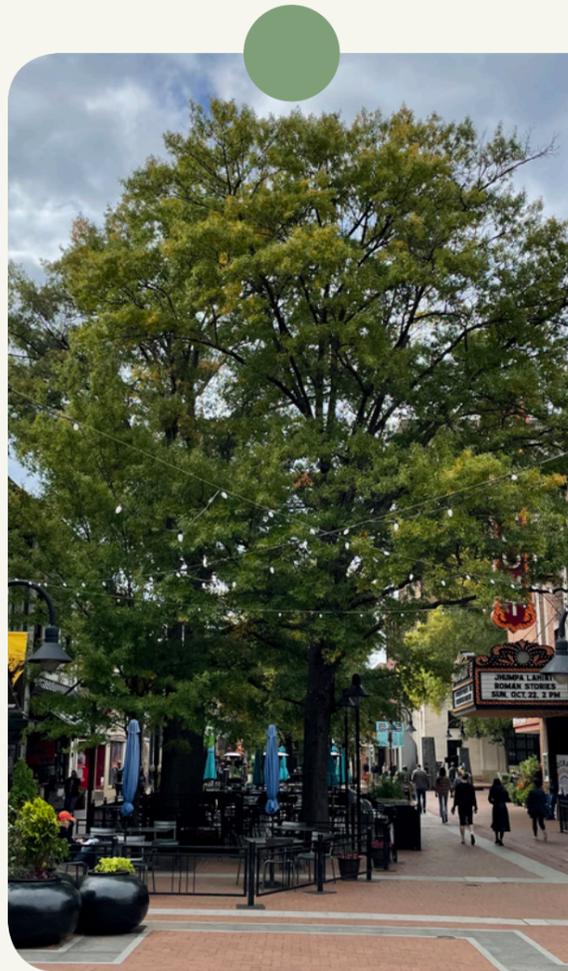
Excellent to Good

- 100% live canopy
- Strong to average annual growth
- Overall healthy condition

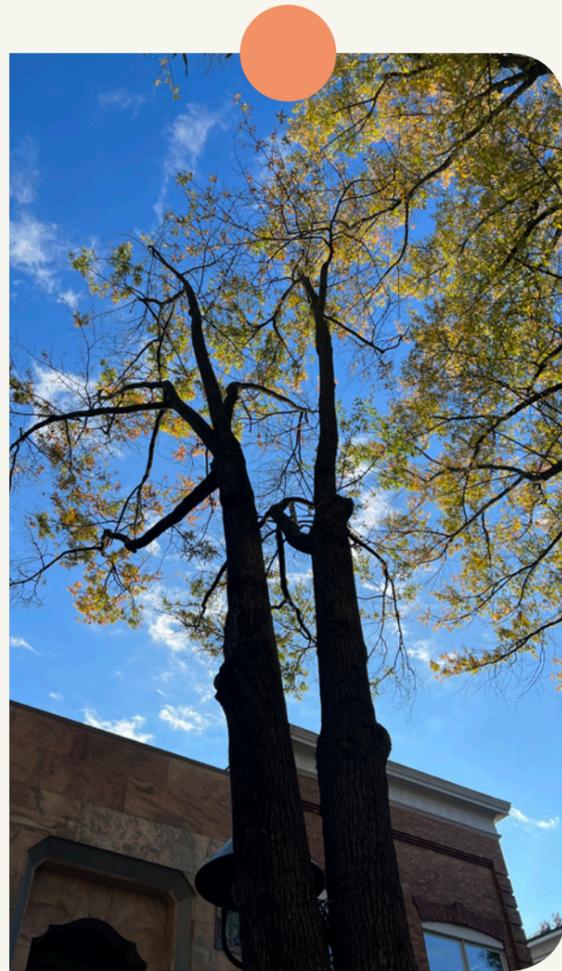
Poor

- 50% - 75% live canopy
- Low annual growth
- Structural defects
- Heavy branch dieback or missing central leader

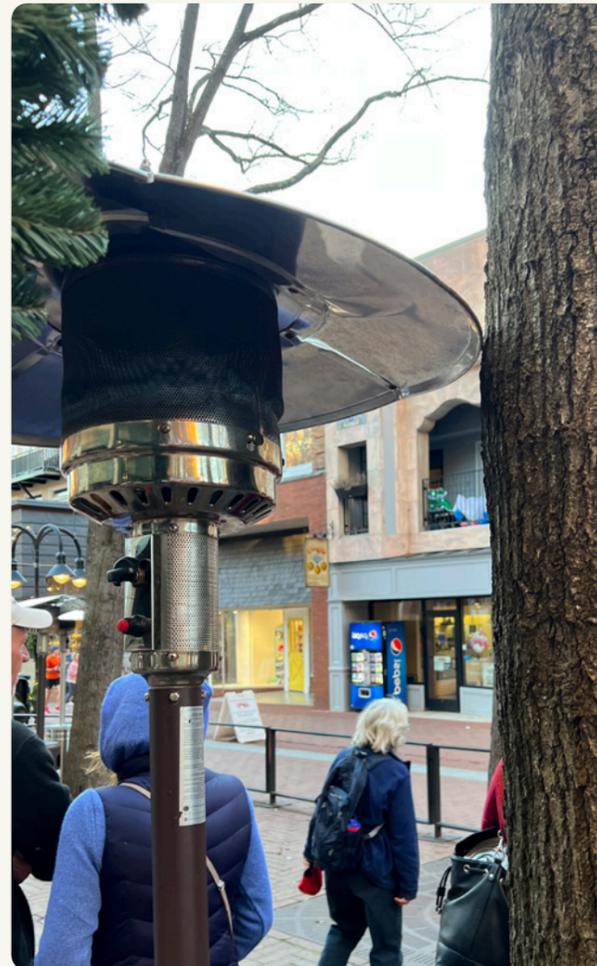
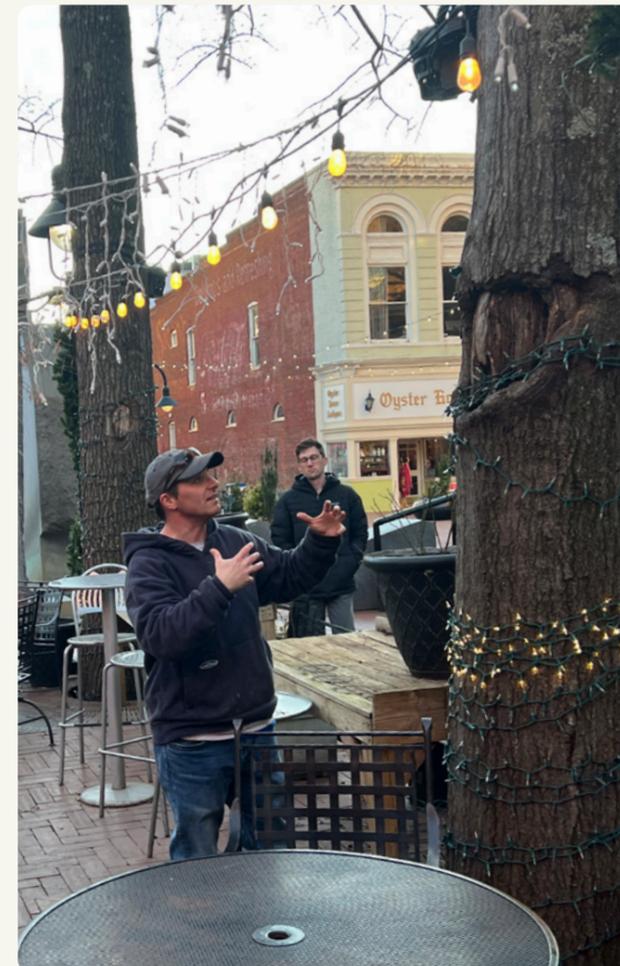
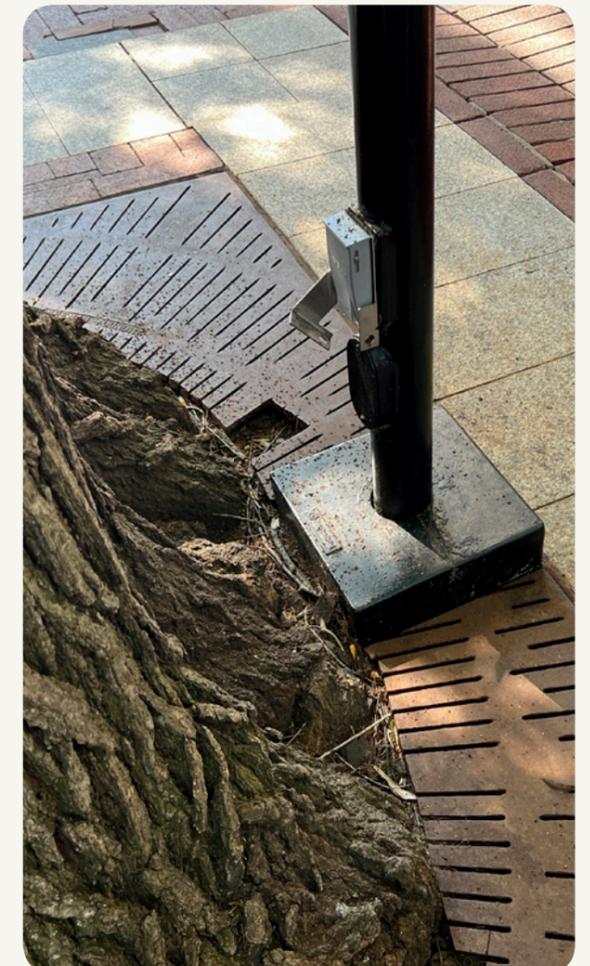
- 9 of 55 original willow oaks were impacted by improper heater use too close to the trees (preventable, human-caused damage)
- 2 of these 9 trees required removal in 2022
- 5 of the 6 cafe enclosures that use heaters near trees have caused the damage
- Light fixtures pose long term health issues to trees and tripping hazard

High risk willow oak #19 removed (1/8/24)

- Minimum 10' clearance from trees
- All heater locations to be approved with NDS
- Penalties include loss of heater usage and possible revocation of cafe space

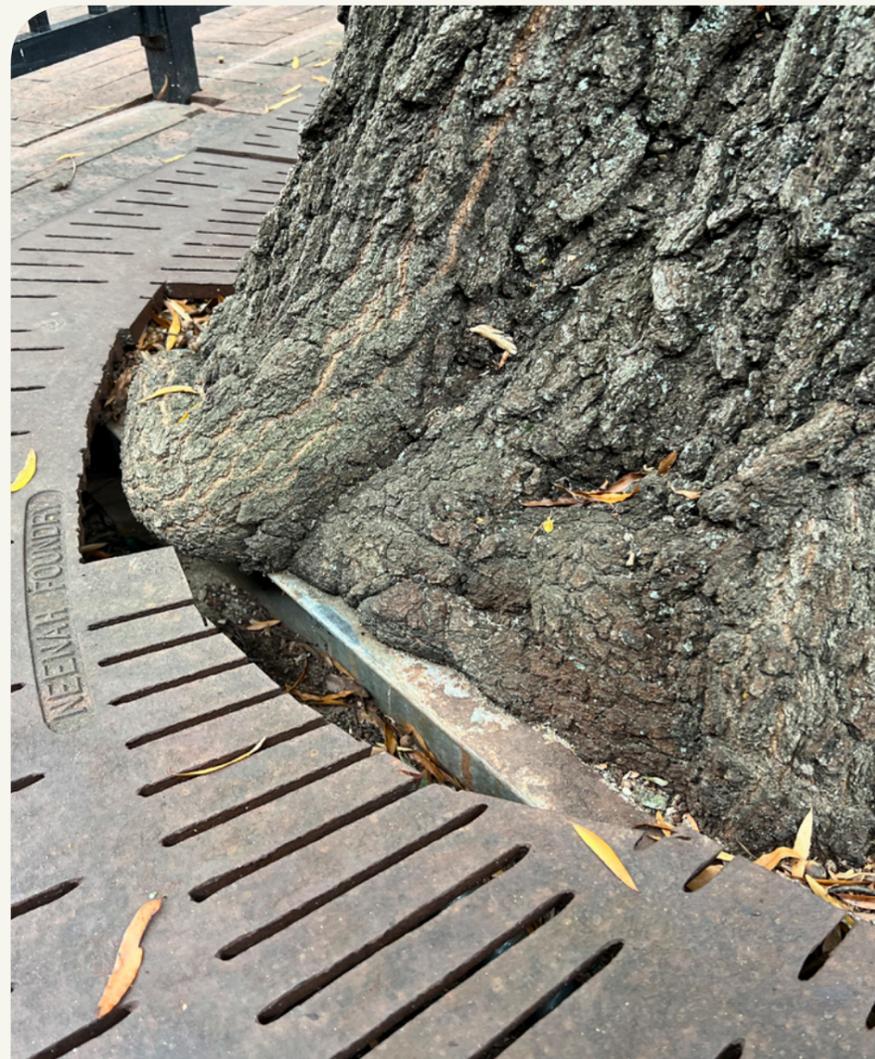
Tree #13

- Tree girdled by grate support beam
- Some trees may be structurally dependent on support beams

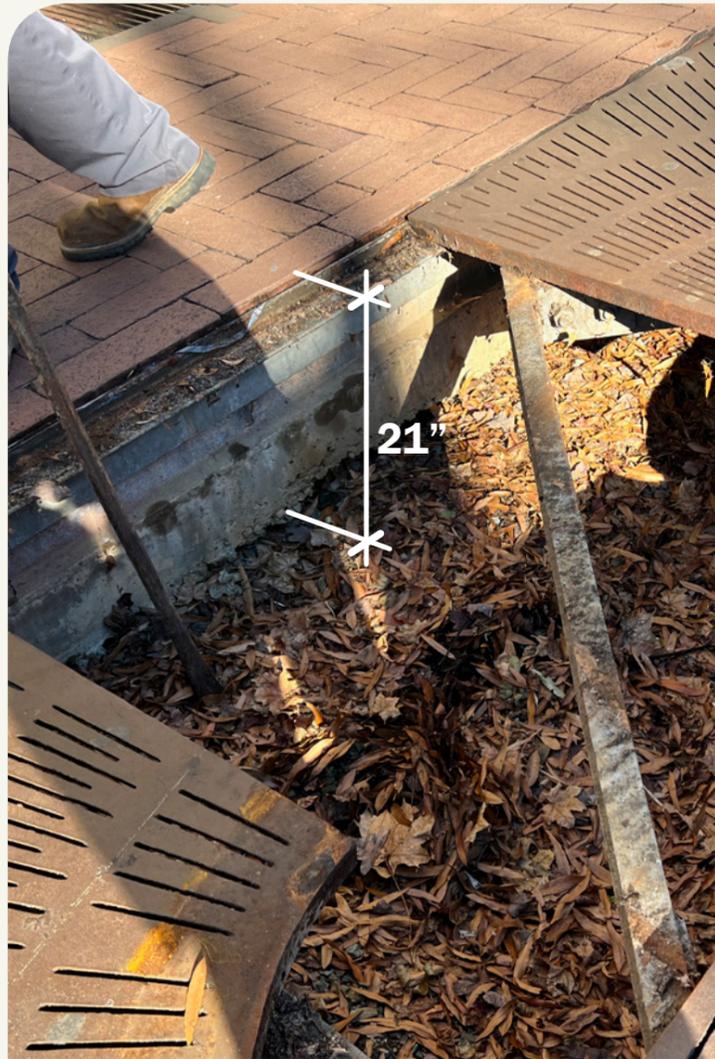
Soil 21" from top of pavement

- 18-24" soil depth allows room for root flare below grate and support beam

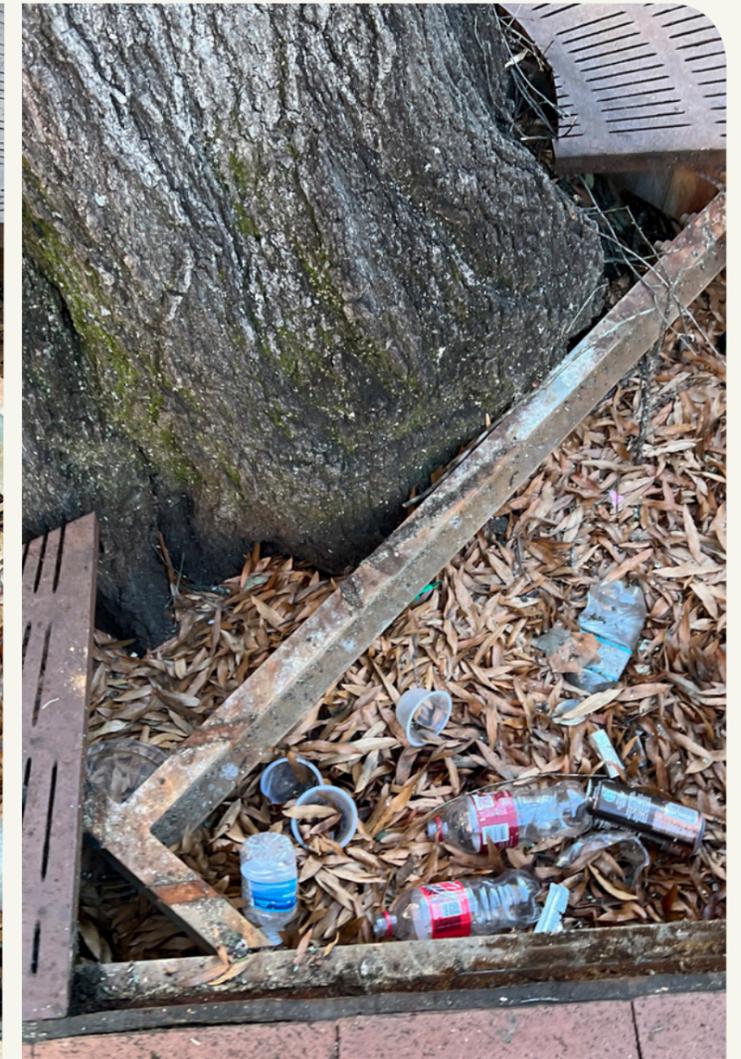
Soil 12" from top of paving

- Shallow soil depth increases trunk flare conflict with grate support beam

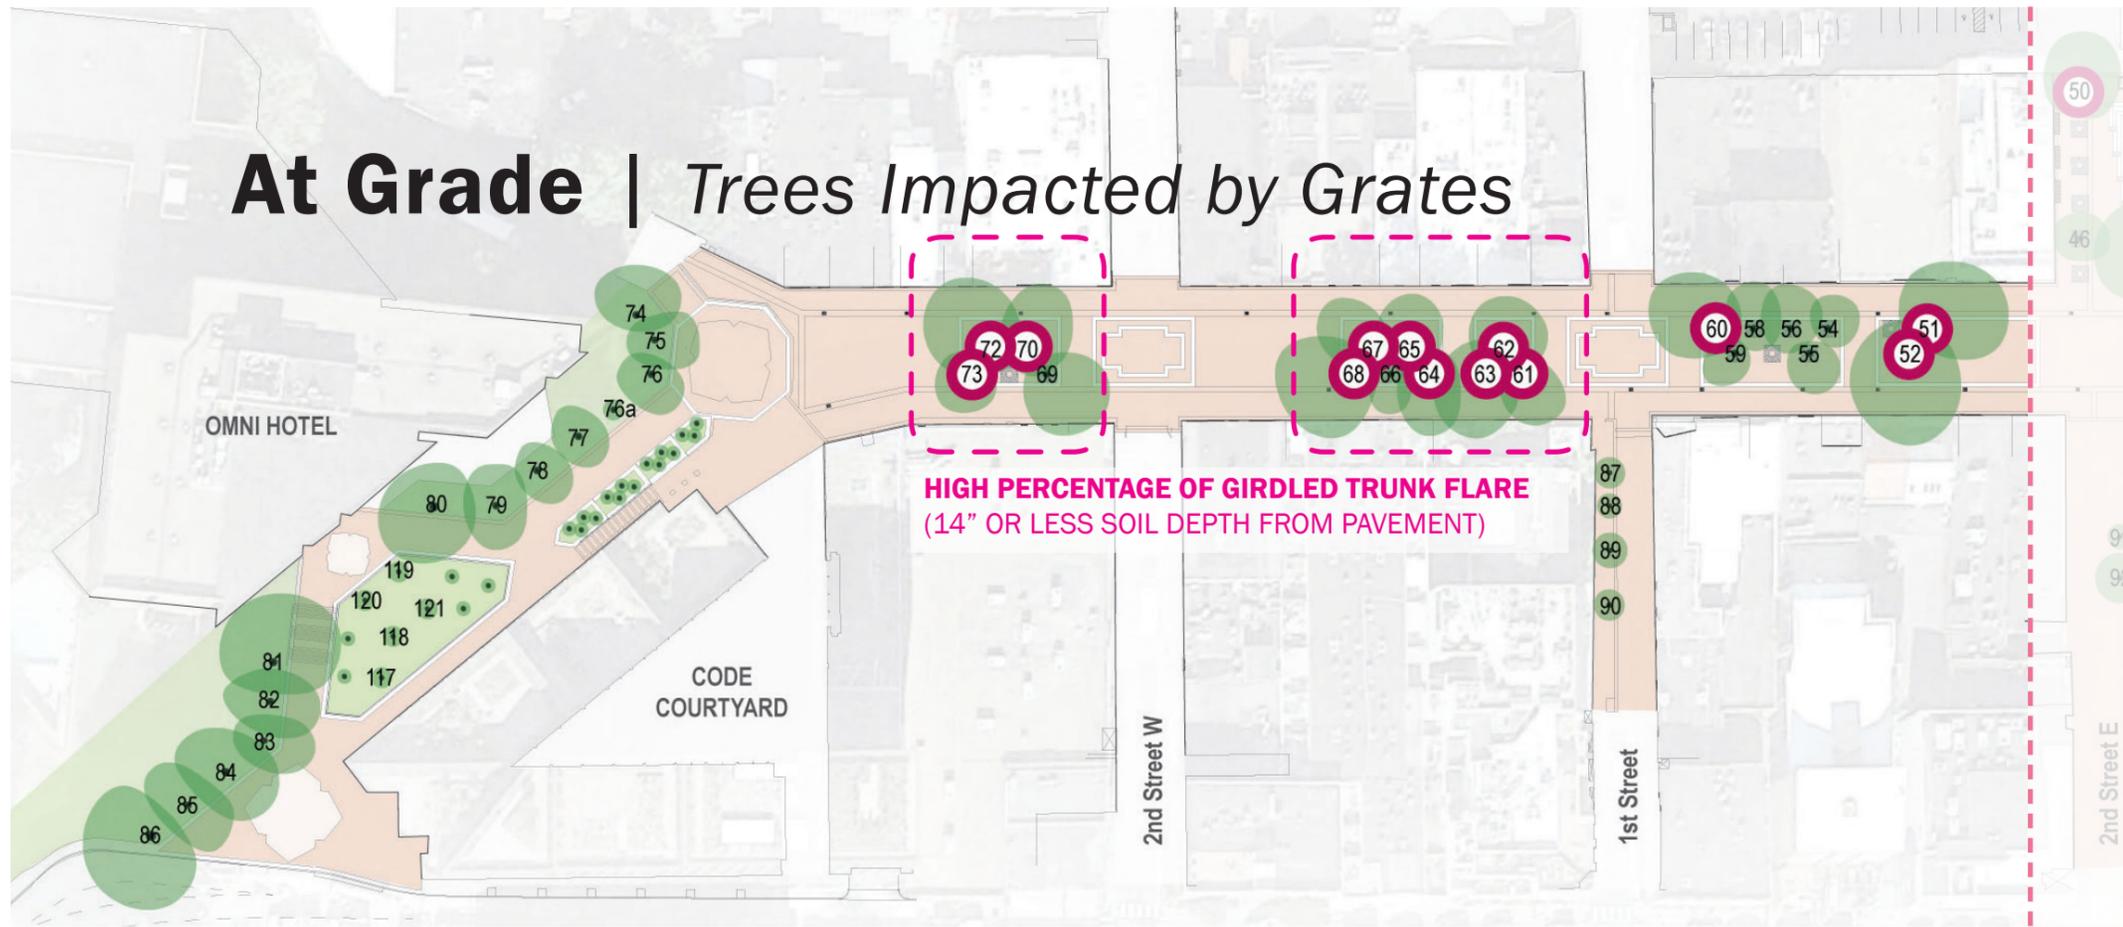
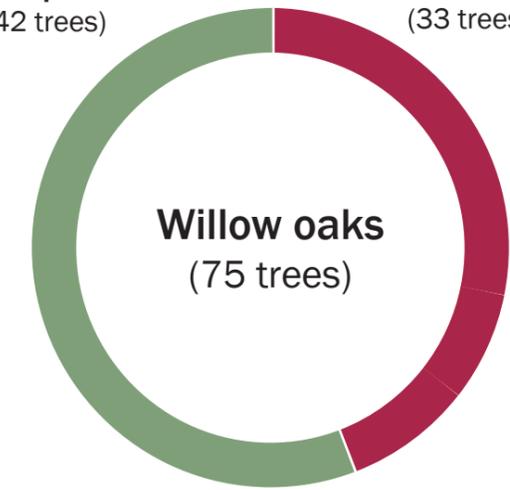
At Grade | Trees Impacted by Grates

56%
No impact
(42 trees)

44%
Grate Damage
(33 trees)

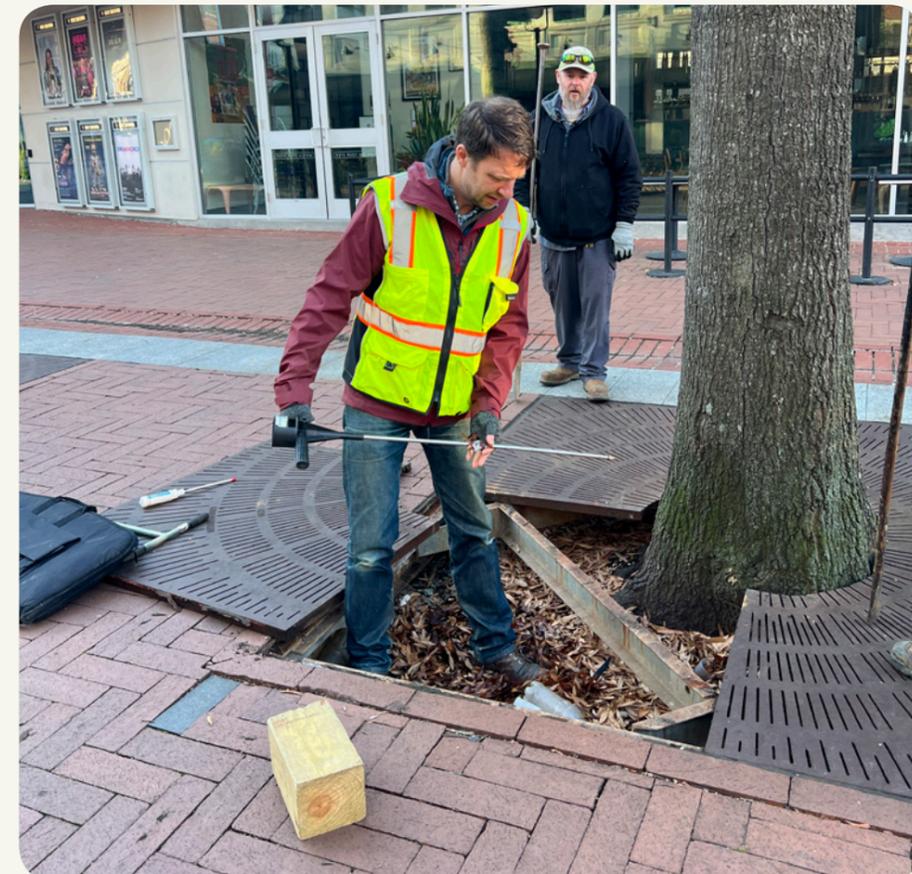
Soil Testing Results

Soil pH: Healthy soil pH overall, slightly higher levels were noted on plan for further observation.

Organic Matter: No observed organic matter concerns.

Cation-Exchange Capacity (CEC): Healthy CEC levels overall, except as noted on plan.

Soil Moisture: Healthy moisture levels overall, except areas of excessive moisture noted on plan.

Soil Compaction: Minimal compaction overall, except as noted on plan.

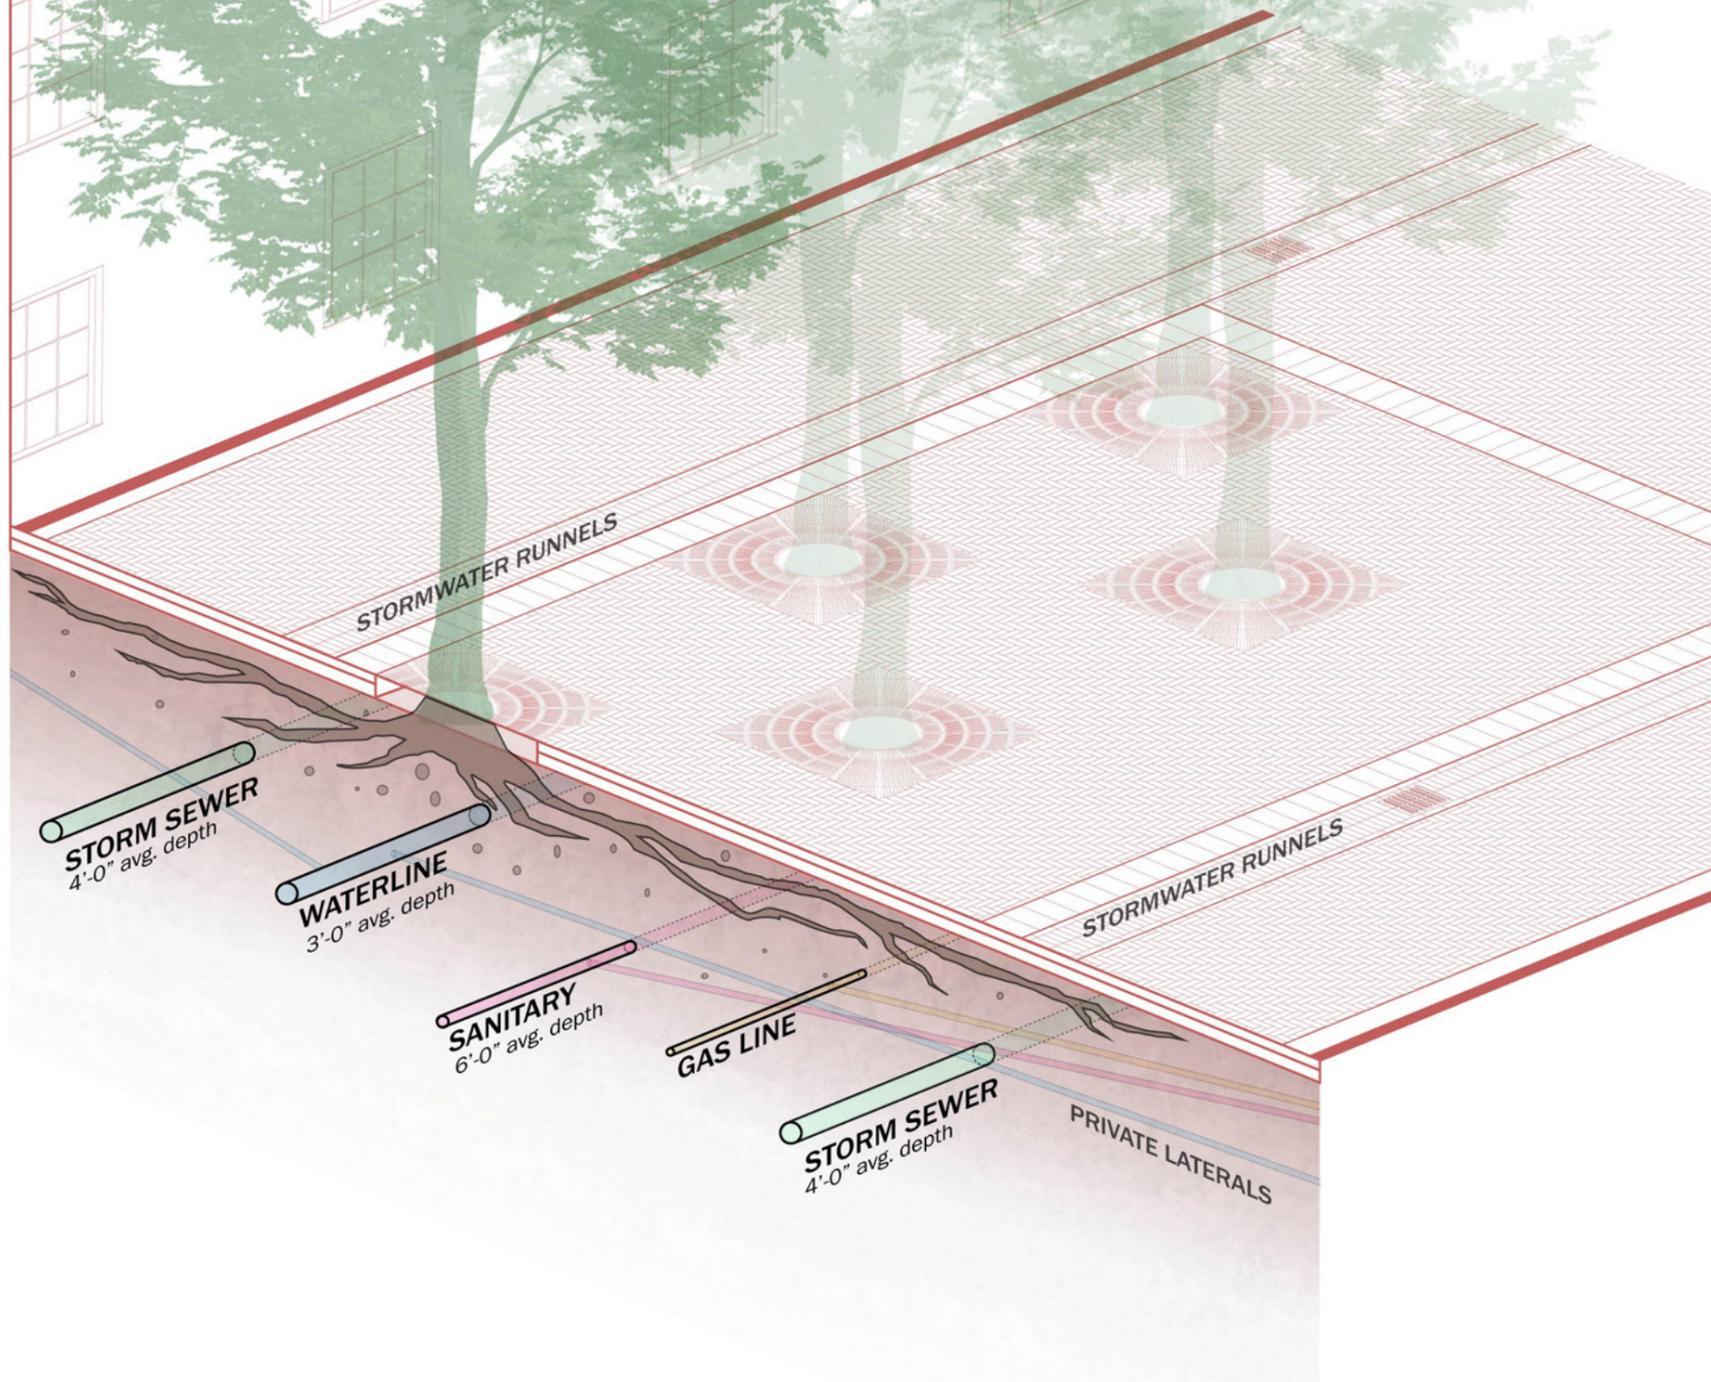
Below Ground | Utilities Observations

- No immediate concern
 - Main lines are low with no apparent negative impacts on utility lines or tree roots
- Long-term relocation recommended to avoid future conflicts
- No known waterlines or fountain leaking

- Pressure lines include water and gas
- Water laterals have a high likelihood of replacement and up-sizing as businesses change use

- Gravity lines include sanitary and stormwater
- Terracotta sanitary laterals may need replacement
- Gravity lines are more difficult to modify than pressure fed lines

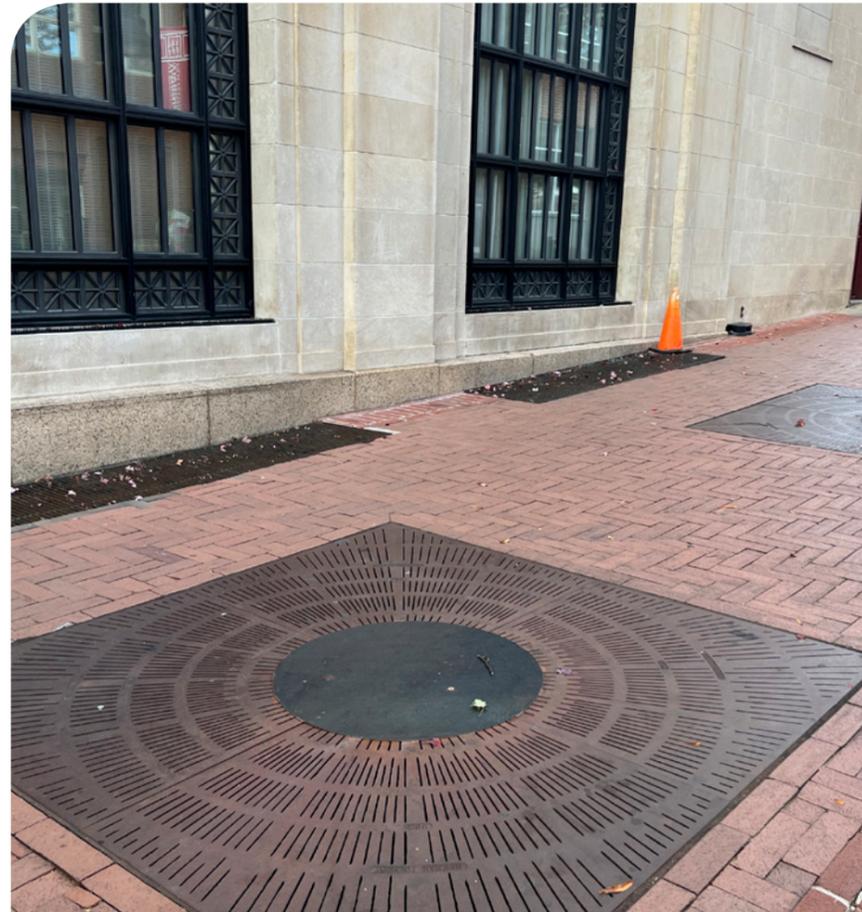
Soil testing in the lower beds near the incomplete Landmark Hotel revealed slightly saturated soil conditions that may be the result of being a natural low spot along the mall, a lack of drainage infrastructure or lack of trees (or a combination of all three). Heavy compaction of adjacent subgrade soils outside of the open planter grate zone was also observed.

LIMITED SOIL VOLUME

- Minimal soil volume between building foundation soils and step footers
- Planted maples have limited urban adaptability and lead to high mortality

Improving upon both of these conditions for future trees, increasing available uncompacted soil volume for future root growth and planter drainage are key improvements. Maples are not recommended for a replacement species due to their inability to tolerate urban conditions.

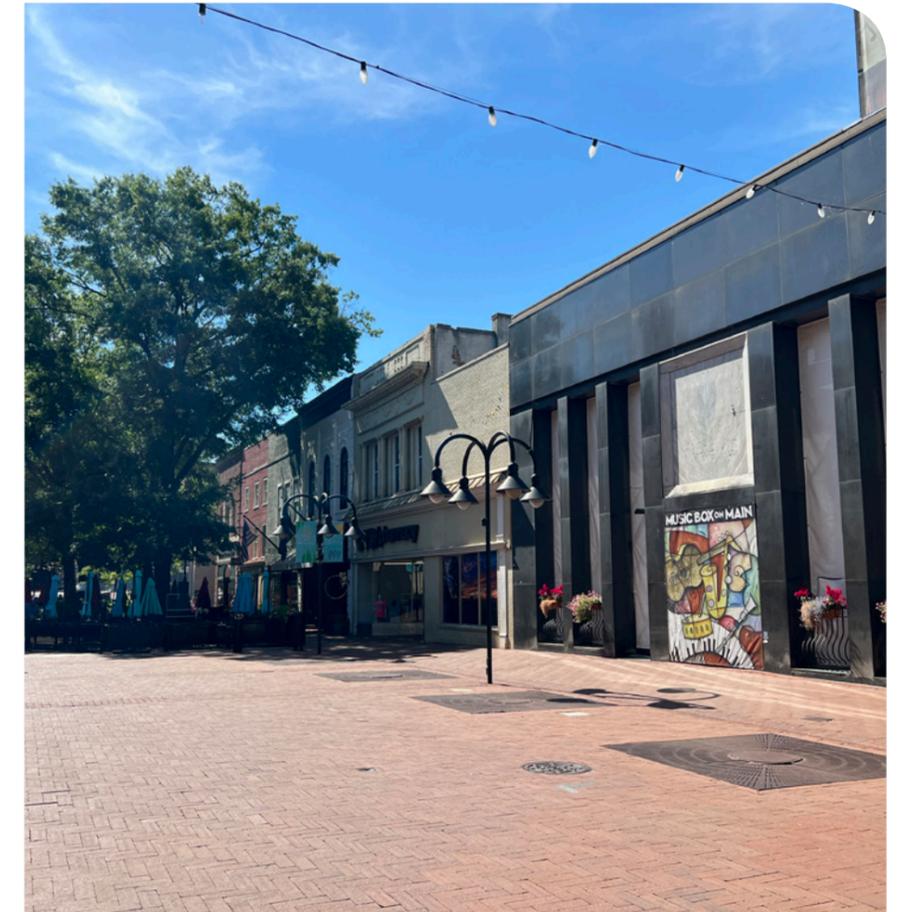
SATURATED SOILS

- No drainage infrastructure and location has led to higher saturated soil levels

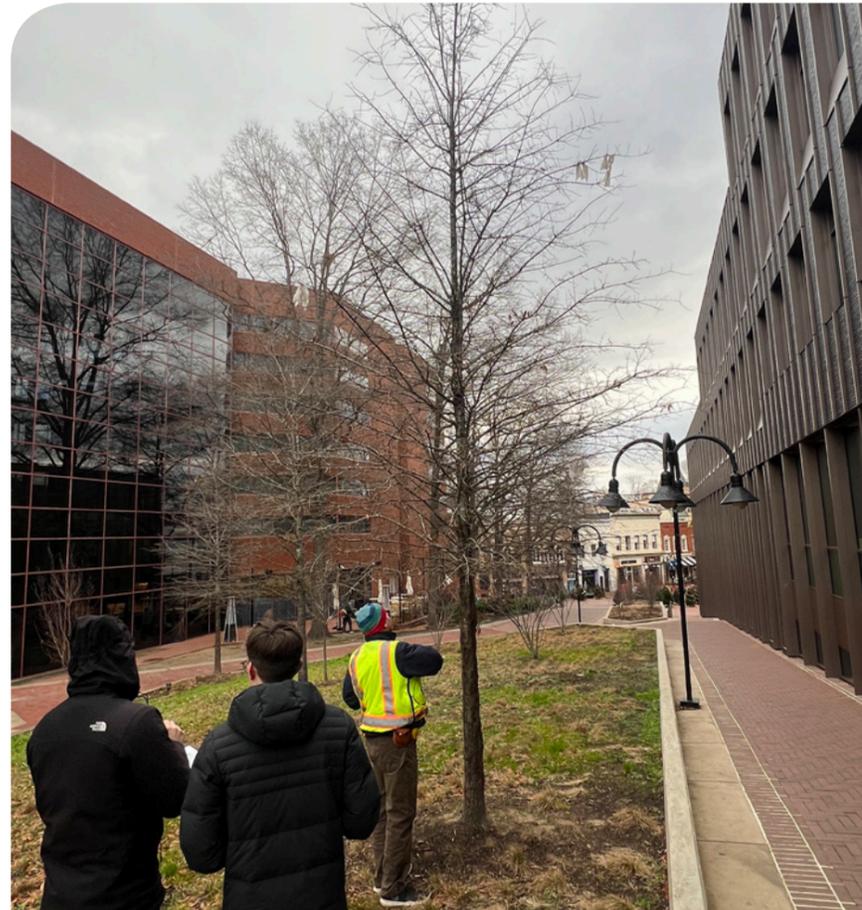
Soil testing in this bed revealed saturated soil conditions and excessive nutrients resulting from manure based compost in the recently installed soil mix.

POOR SOIL QUALITY

- Screened clay soil limits air and gas exchange
- Manure based fertilizers lead to high weed presence

- Replace poor draining, screen soils with unscreened planting soils and provide internal planter drainage

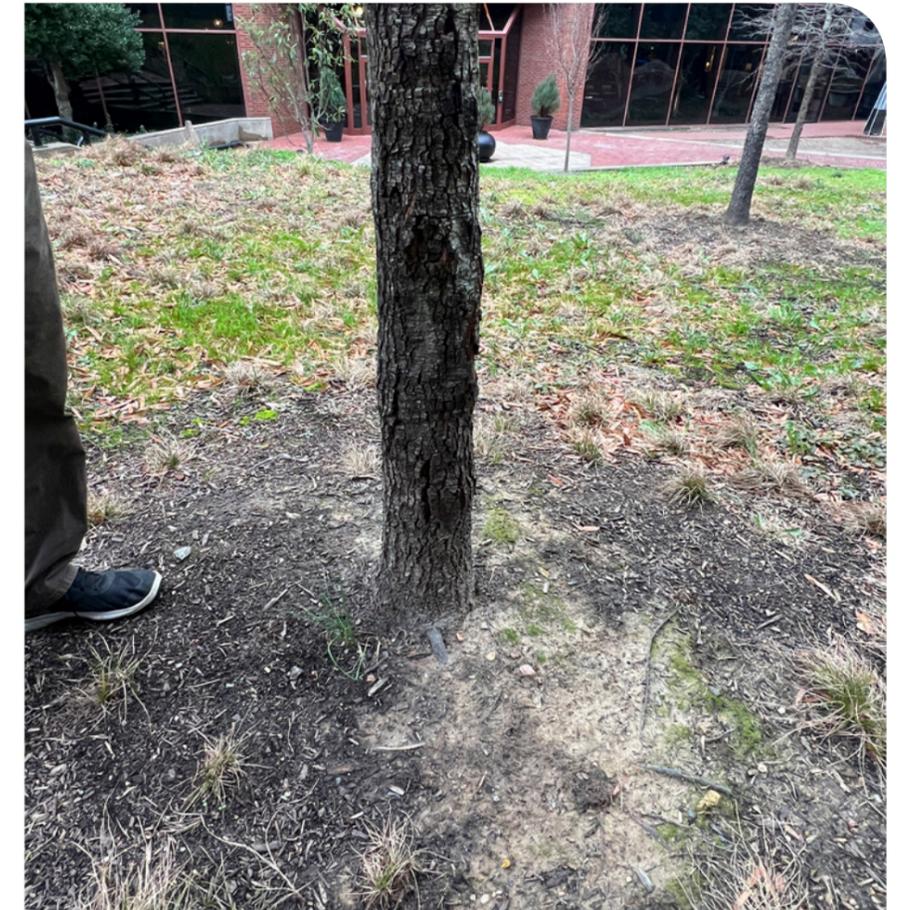
SATURATED SOILS

- Lacking pore space, the soils are unable to drain, leading to high plant mortality
- No drainage infrastructure

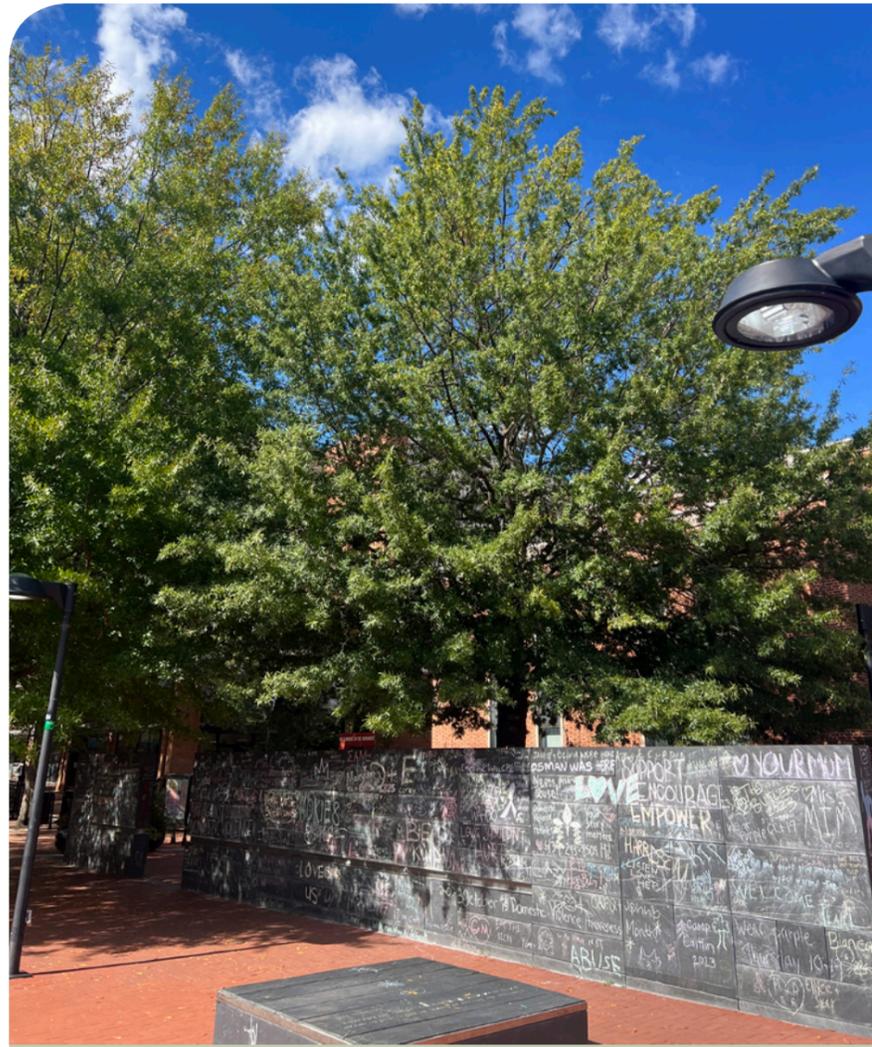
OVERALL CONDITIONS

- Trees are generally healthy
