Charlottesville Downtown Mall **TREE MANAGEMENT PLAN**

RECOMMENDATIONS + APPENDICES

2024

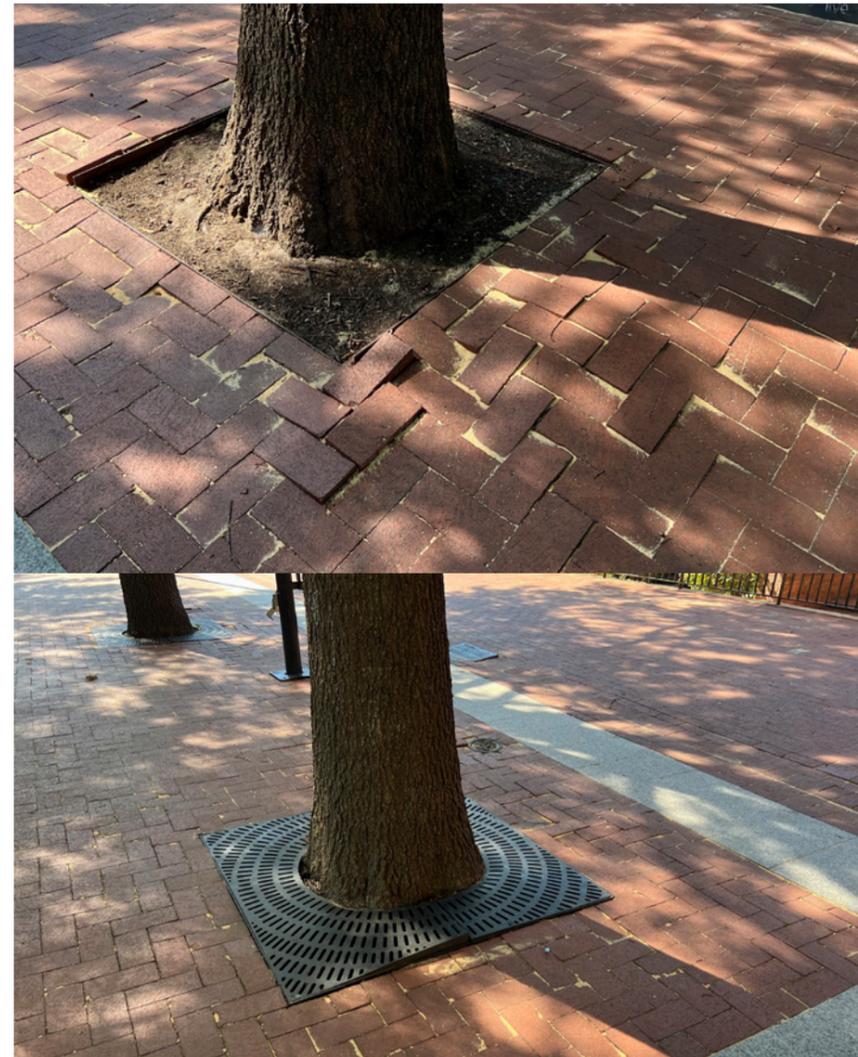
GRATE CONFLICTS

- Surface roots between slab and pavers leading to trip hazards
- Hidden steel paver grate girdling trees

Surface and feeder roots were observed moving into the sand setting bed between the adjacent pavers and concrete subslab. One tree in this grove has been removed and is not recommended for replacement due to existing canopy competition that would compete with the existing trees.

A hidden paver grate system, consistent with nearby installations, is assumed and suggested for removal. Pruning of surface roots and the installation of a root barrier at the end of the planter will prevent future root/paver conflicts.

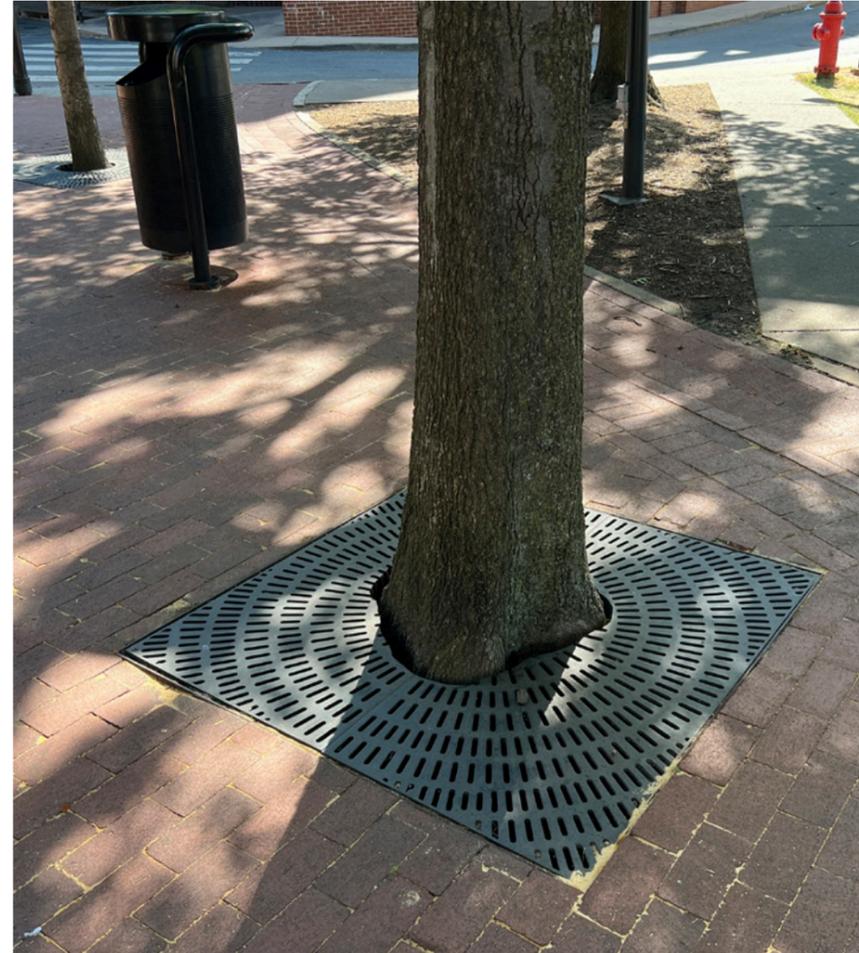
GRATE CONFLICTS

- Steel substructure frame supporting pavers and grates are girdling trunks limiting water and nutrient exchange

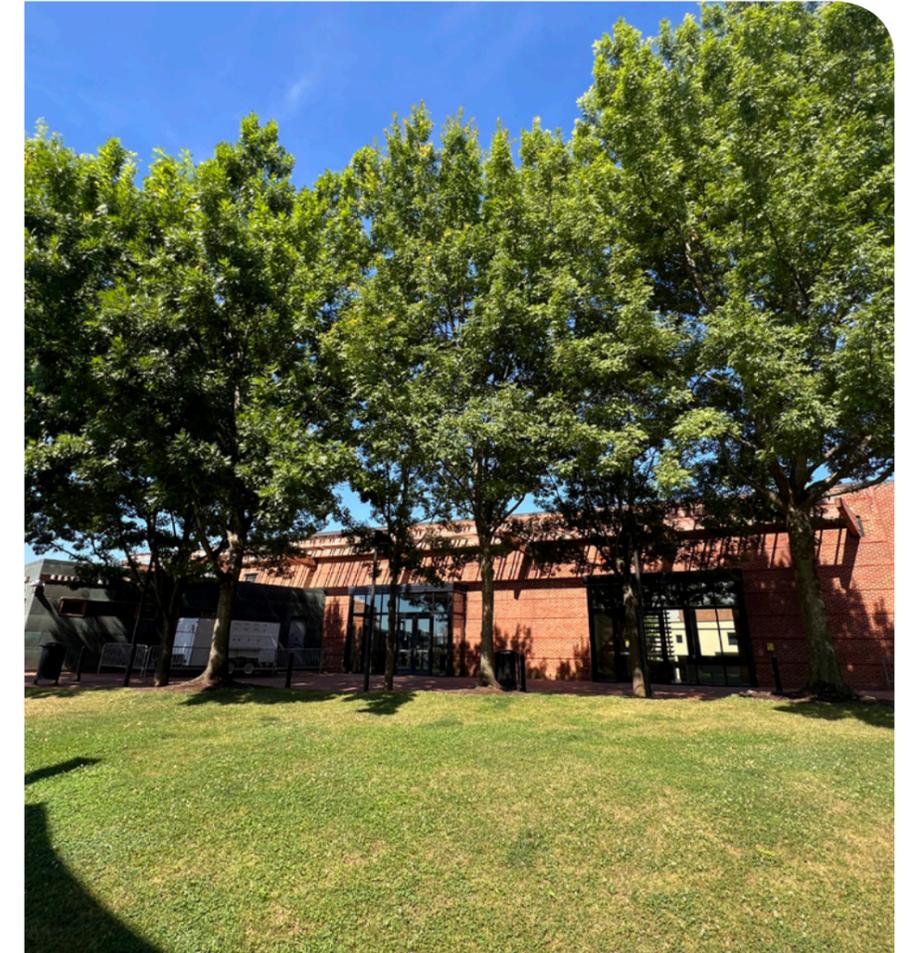
CANOPY CROWDING

- Selectively prune & remove designated trees to reduce crown competition

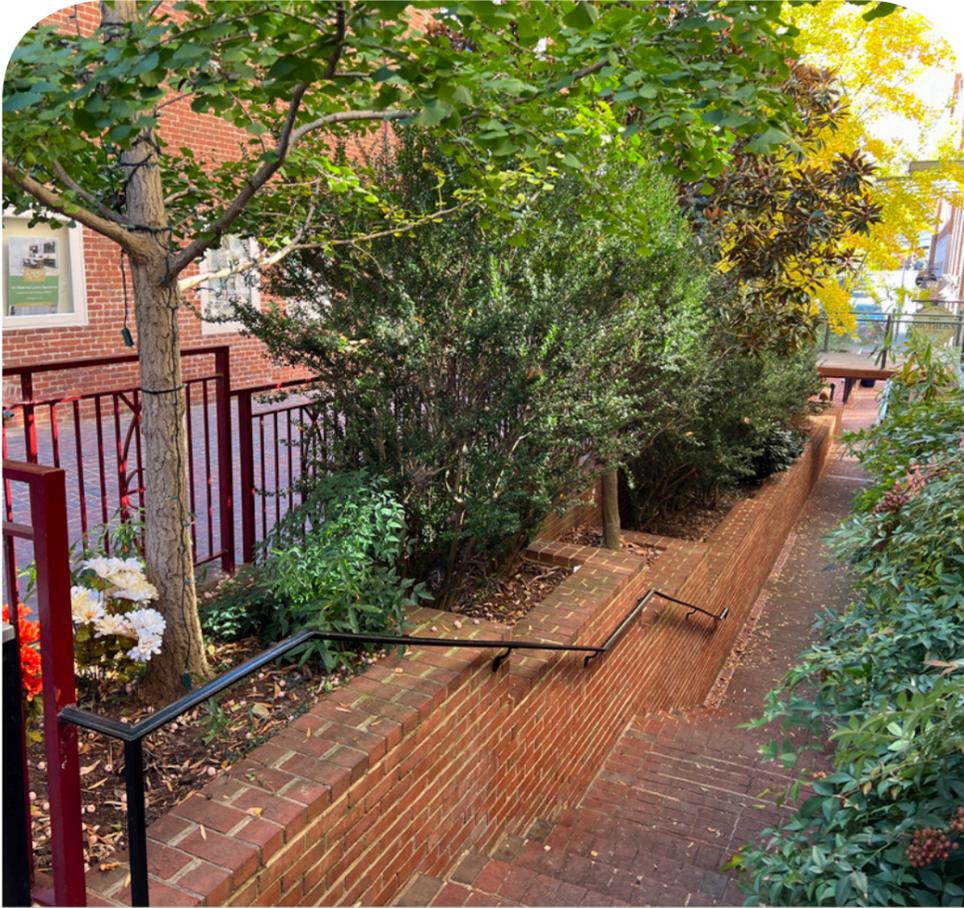
OPEN PLANTERS

- Narrow open planters between 1st St and a lower access path offer lush vegetated views while partially screening views of nearby parking lots

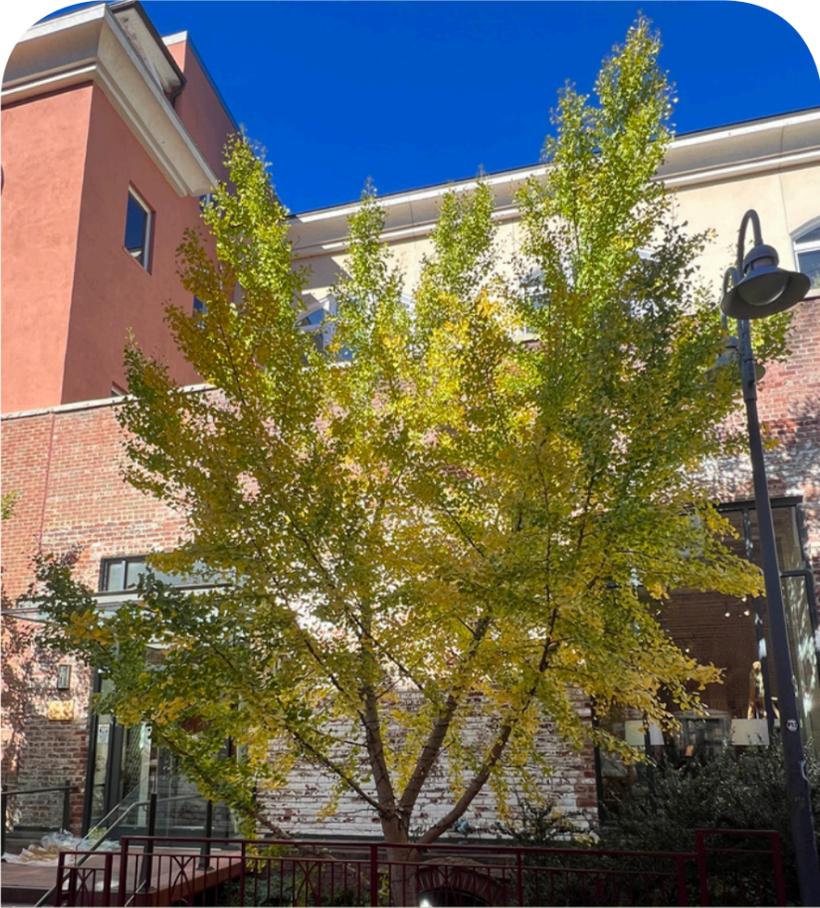
LIMITED SOIL VOLUMES

- Currently healthy, as the ginkgos grow within their contained planters, their health and growth will likely be stunted by limited soil volume

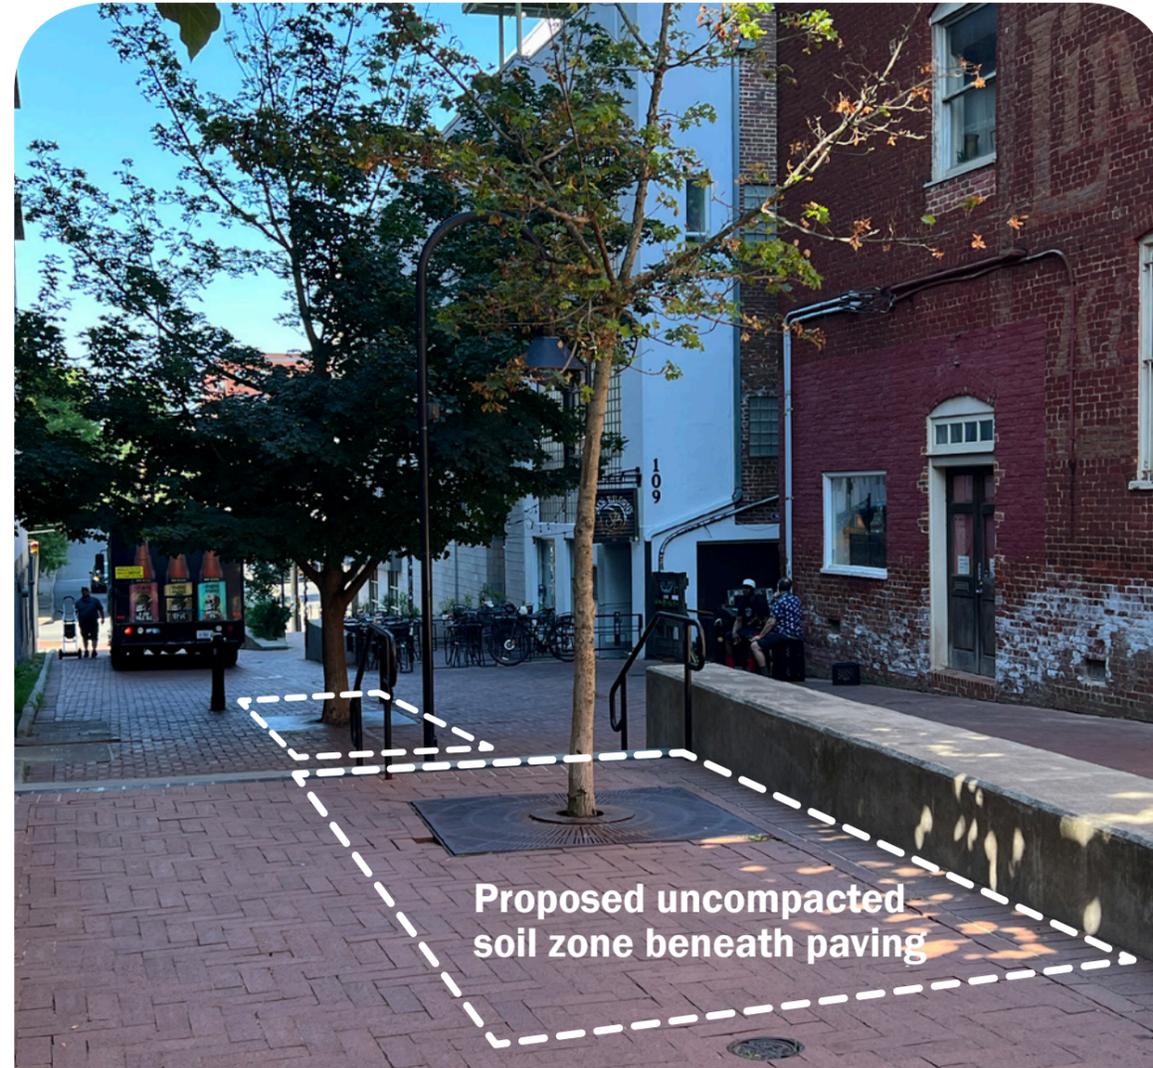
Proposed uncompacted soil zone beneath paving

The replacement maple cultivars from 2009 have largely failed with ten out of the twelve planted dead or near dead. Outside of the ~5' tree grate zone, the soils are heavily compacted creating a limited available soil volume. While some urban trees are adapted to difficult soils, maples regularly fail in compacted soils.

LIMITED SOIL VOLUME

- The maples along 2nd St SE are in poor health and decline due to limited uncompacted soil volume

Increasing the available uncompacted soil volume through suspended paving systems is the main priority in this area. Selecting replacement trees outside of the proposed Mall tree species provides an opportunity for greater resiliency and species diversity.

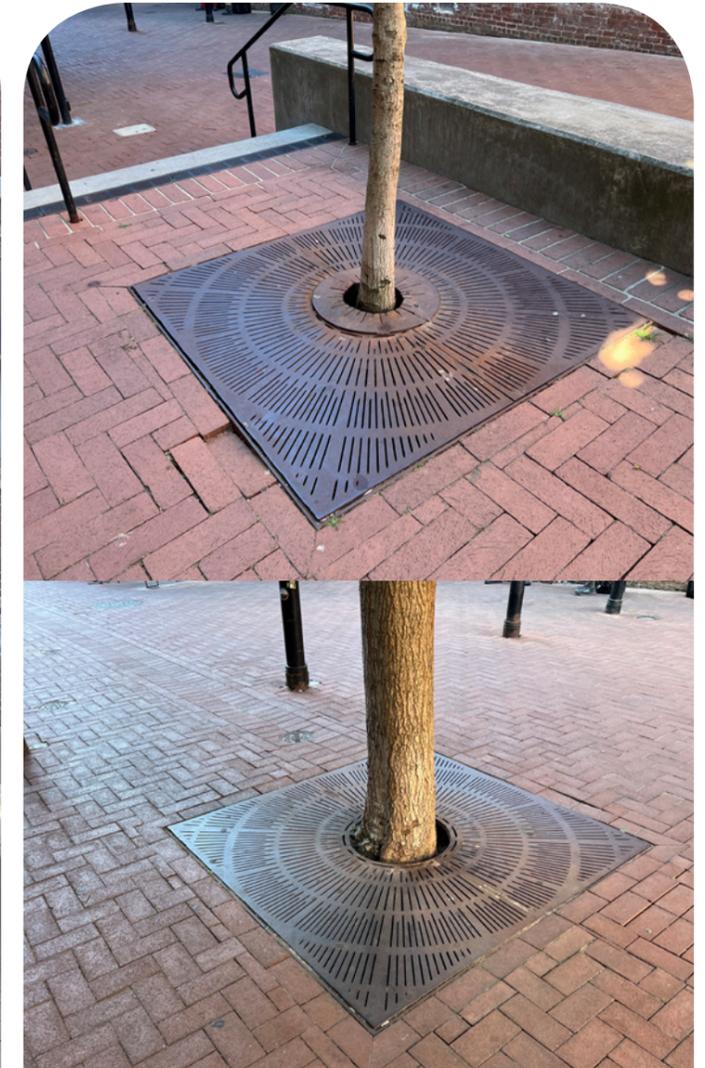
GRATE CONFLICTS

- Tree grates and their substructure frame have created trunk girdling conditions and bark wounding

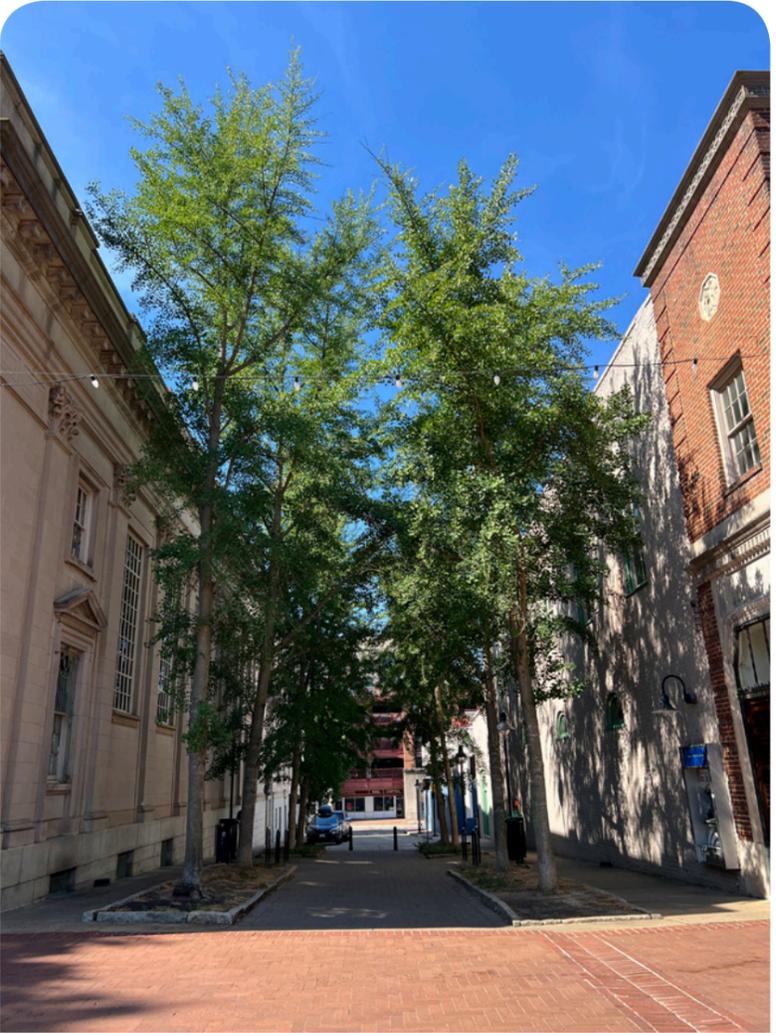
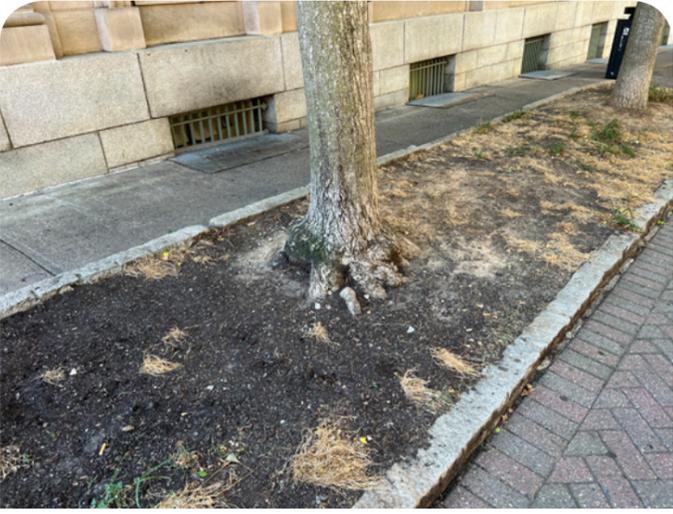
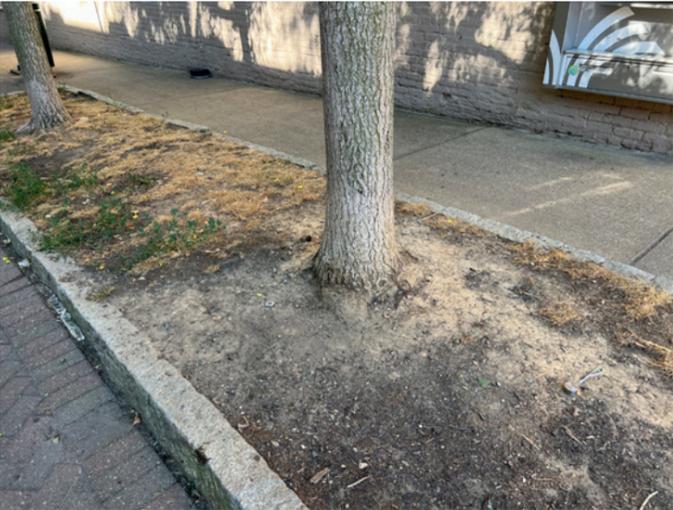
Despite limited uncompacted soil volume, ginkgos are adept at succeeding in compacted urban conditions and these are in good condition. The exposed soil they are in has surface compaction and is partially planted in groundcovers.

COMPACTED SOILS AND UNSUCCESSFUL GROUND COVER

- The Ginkgos along 3rd Street E (South) are currently in good health
- The trees would benefit from soil remediation and mulch

To improve the trees and viability of planting soil to sustain groundcovers, it is proposed to decompact the surface soils 5' from the trunks and blend in compost with compressed air.

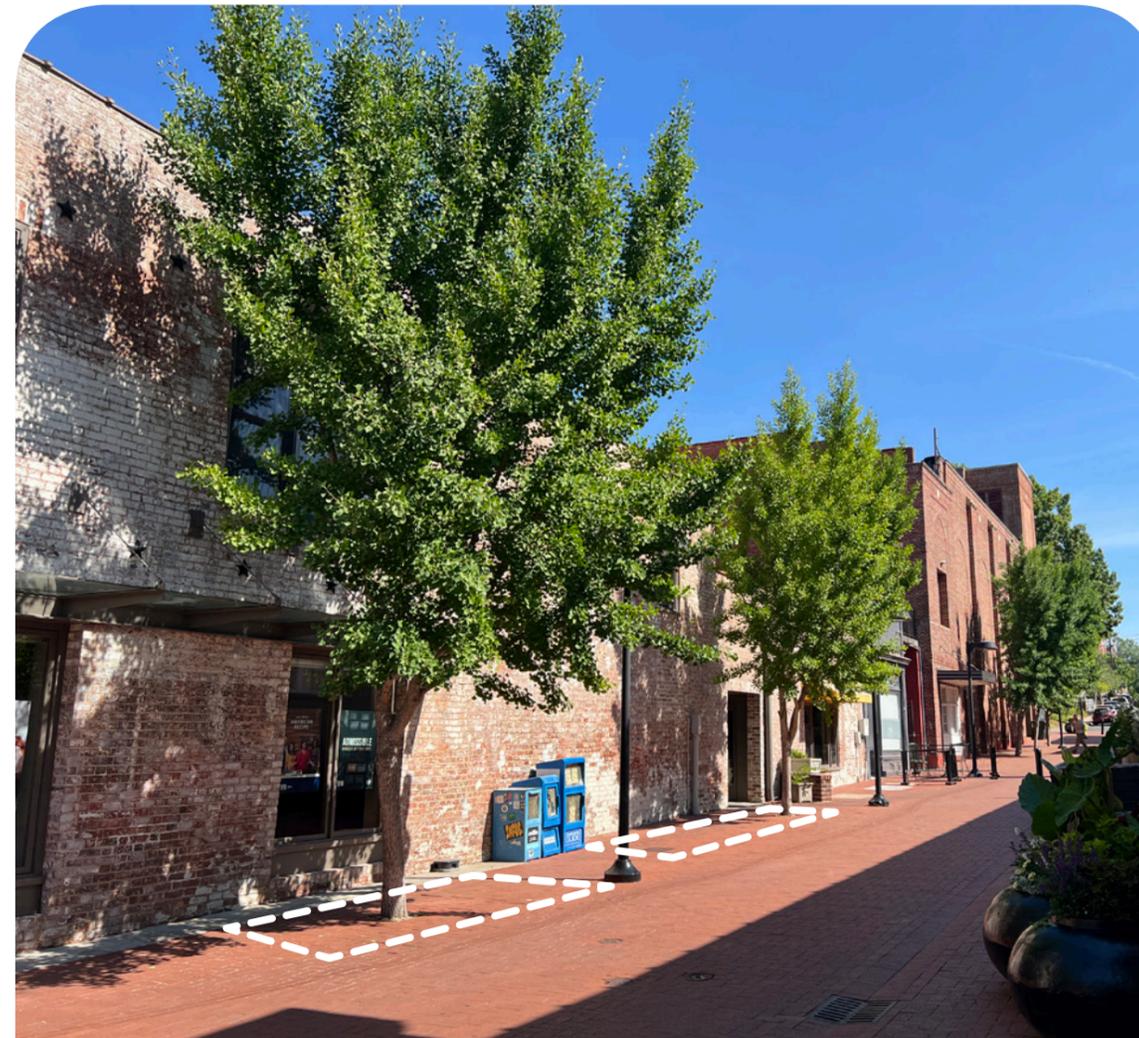
Despite limited uncompacted soil volume, ginkgos are adept at succeeding in compacted urban conditions and, apart from one removal, these are in good condition. Consistent with the other 2009 tree installations, a hidden paver grate system is assumed and beginning to girdle the remaining trees.

CONFINED LOCATION

- The Ginkgos along 3rd Street E (North) are planted very close to the buildings, resulting in an asymmetrical canopy.

To improve the planting soils surrounding the trees, prevent trunk girdling by narrow paver openings, and increase vegetated views off the Mall, it is proposed to remove the paver grates and study opportunities that would increase low shrub and/or perennial plantings within these areas. Include rat barrier wire mesh 6" below the surface of new planting soil and mulch.

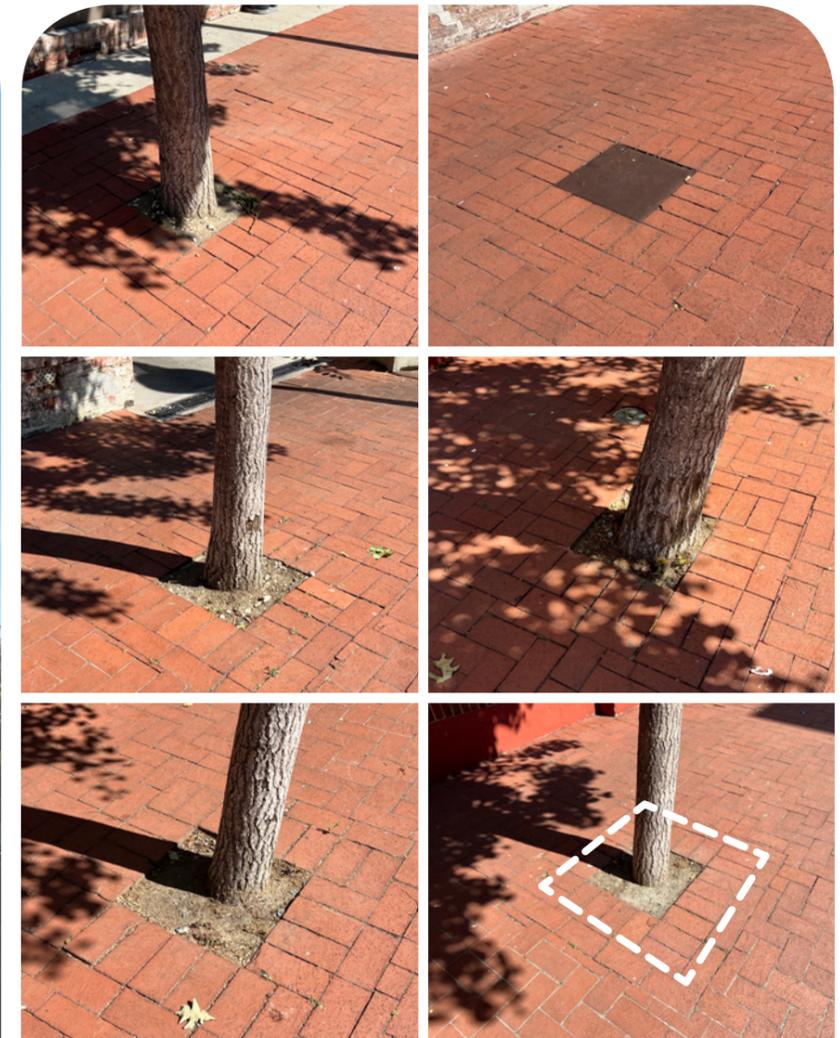
SOIL COMPACTION

- Growth appears to be stunted due to limited access to soil and soil compaction

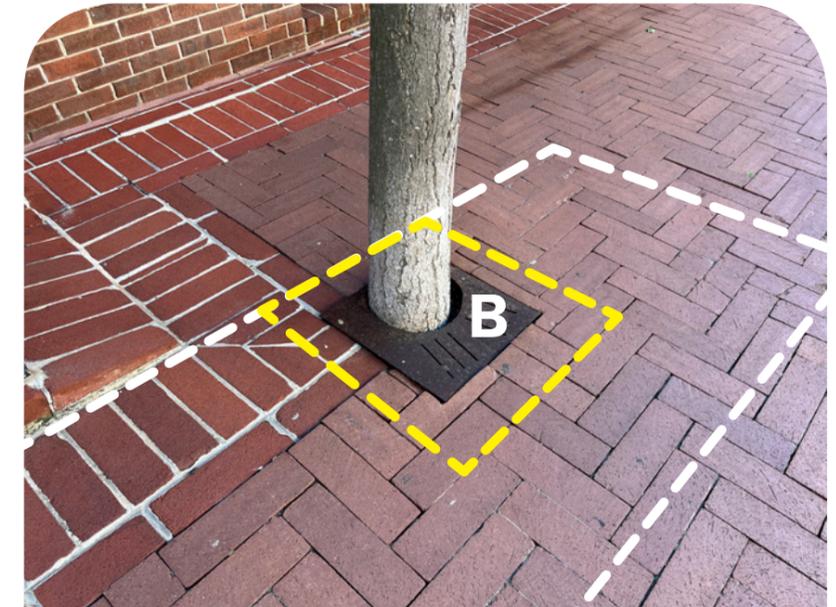
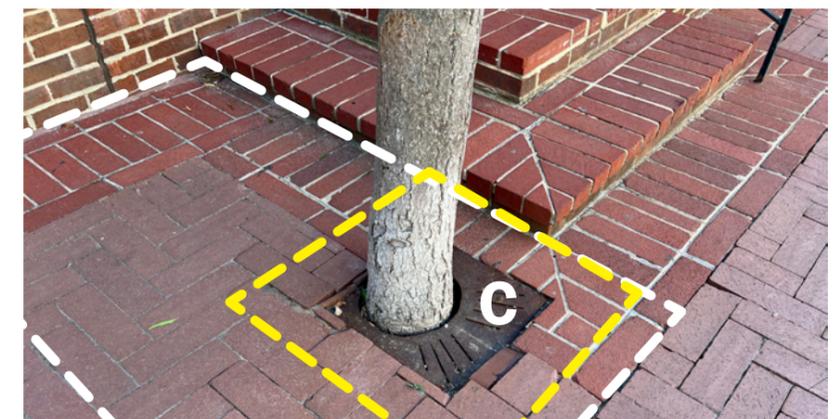
GRATE CONFLICTS

- Trees along 5th St SE have trunk damage due to grate conflicts. At minimum, provide expansion of hidden grate opening (yellow).

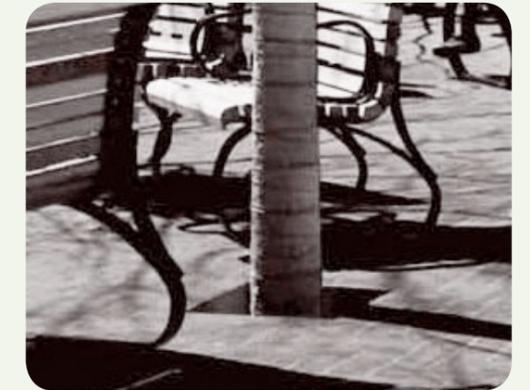
16"x16" Tree Opening*

*Original Halprin design

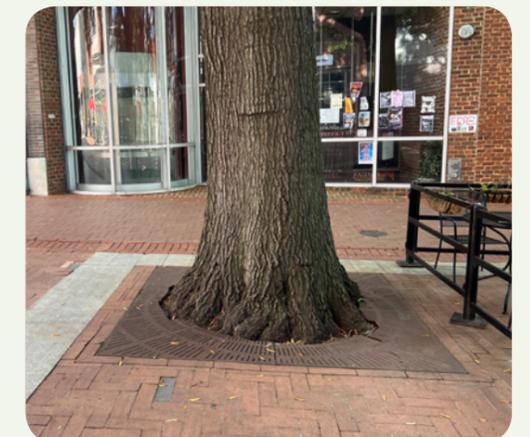
8' x 8' Tree Grate

*Current design

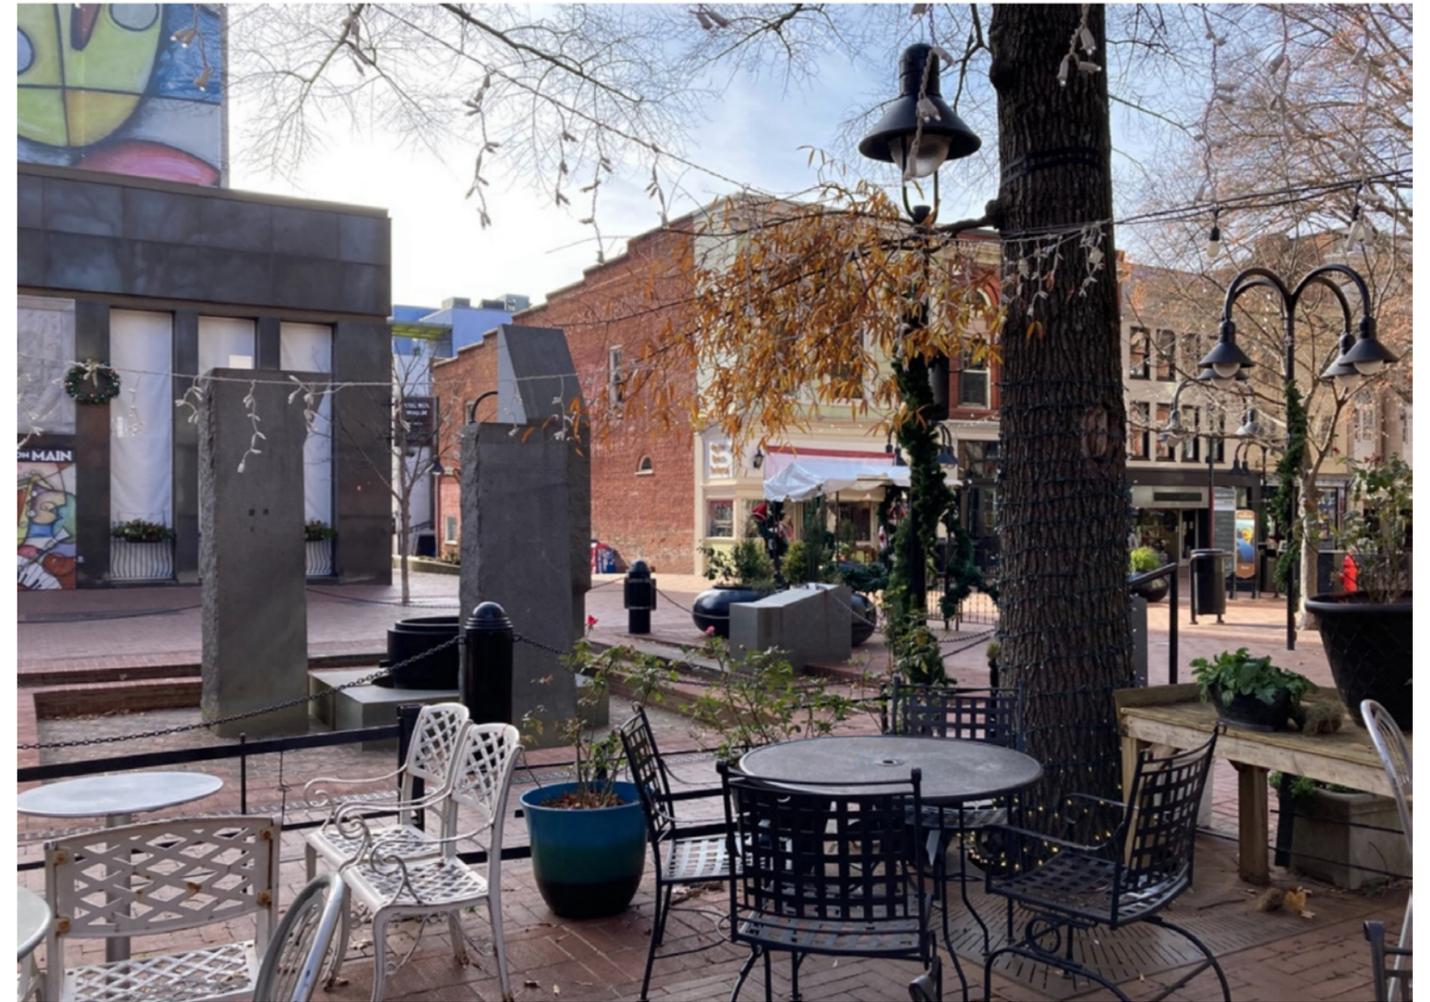
Private amenities restrict circulation and contribute to visual incongruity

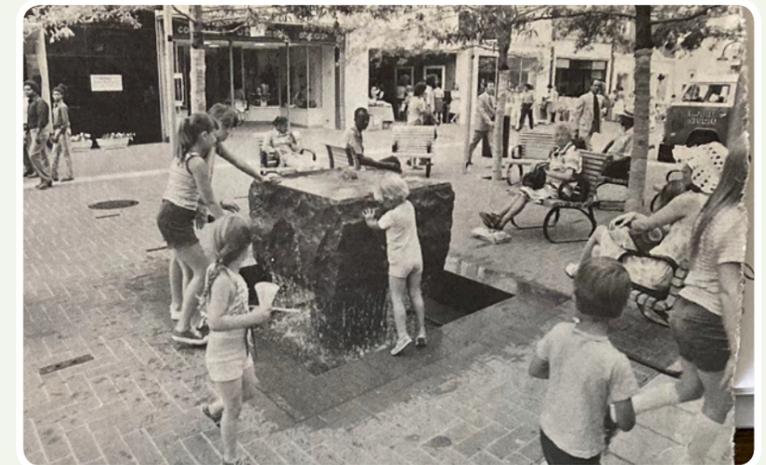
Historic: Public access to fountains

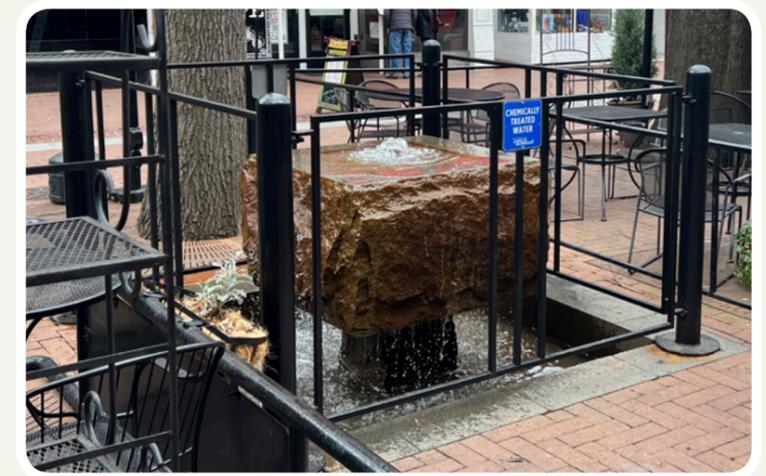
Current: Fountains gated or blocked off

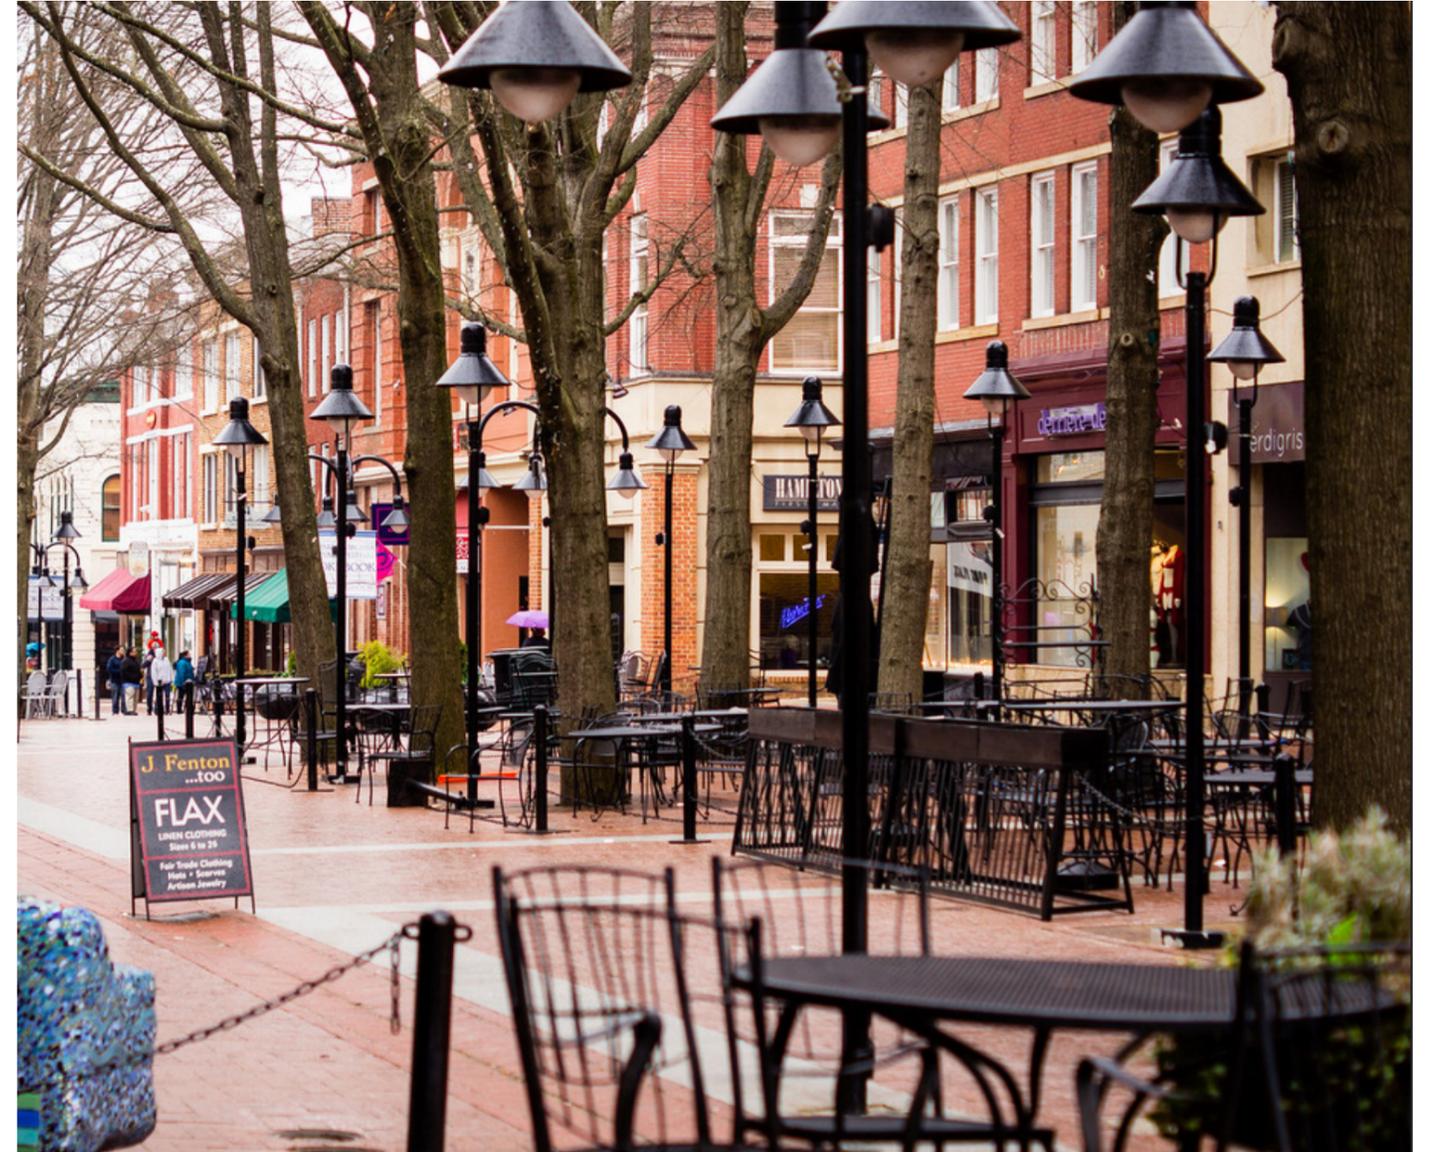
Cafe zones generate economic revenue but declare the trees as private
